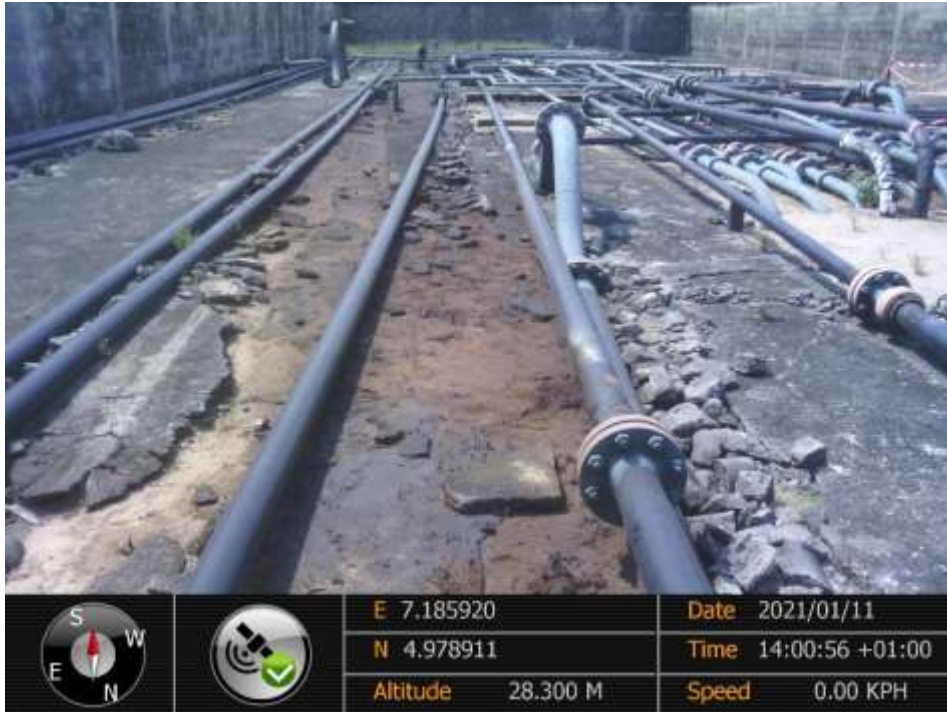
Overview: Part of spill impact on 4inch Imo River well 22s Flowline at Owaza. Picture was taken during Joint Investigation of 11th January 2021.

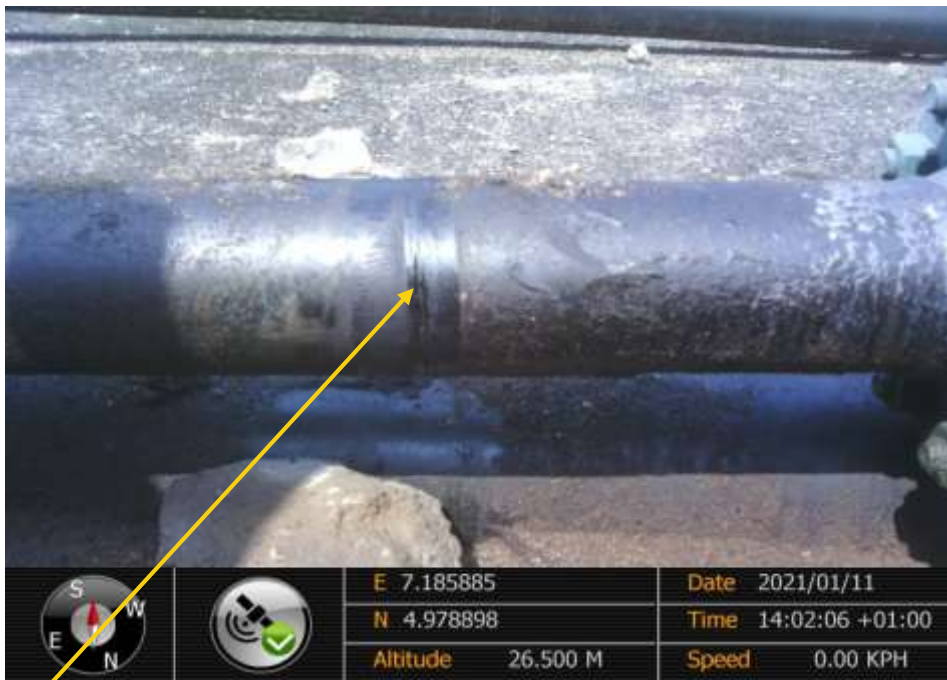
Close-up: Hacksaw cut from 7o'clock to 11o'clock position on 4inch Imo River well 22s Flowline at Owaza. Picture was taken during Joint Investigation of 11th January 2021.
