# JOINT INVESTIGATION REPORT

INCIDENT NO: 2828861 JIV report S/N: 0630

1. Fountain Incident Number: 2828861 2. Type of incident\* OIL SPILL  
3. Name of Location 4<sup>th</sup> IMO RIVER WELL 22S FLOWLINE  
4. Name of nearest community OWAZA 5. State: ABIA 6. LGA UKWA WEST  
7. Production Facility/Installation FLOWLINE  
8. Asset Owner/Hub THE SHELL PETROLEUM DEVELOPMENT COMPANY OF NIGERIA LIMITED (SPDC)/LAND EAST HUB

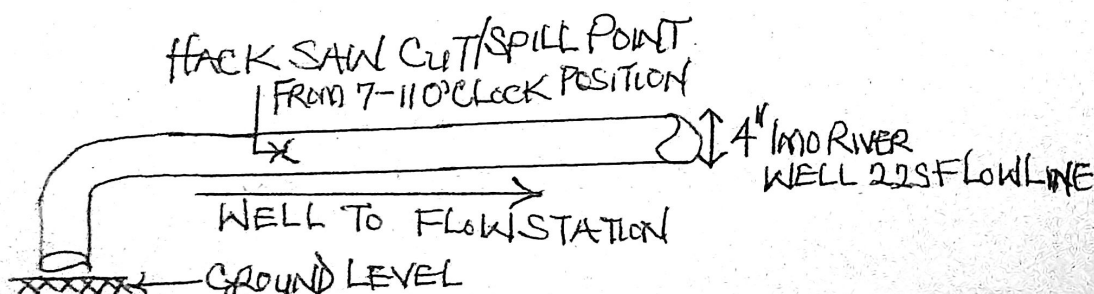
A SECTION OF 4" IVD RIVER WELL 22S FLOW LINE AT ONAZA SHOWING A HACK SAW CUT FROM 70'CLOCK TO 110'CLOCK POSITION BY UNKNOWN PERSON(S)
