# JOINT INVESTIGATION REPORT

INCIDENT NO: 2839807 JIV report S/N: 0665

1. Fountain Incident Number: 2839807 2. Type of incident\*: OIL SPILL  
3. Name of Location: 14" OKOROA RUMUEKPE TRUNKLINE  
4. Name of nearest community: UKPELIEDS, State: RIVERS 6. LGA: AHOADA WEST  
7. Production Facility/Installation: OIL PIPELINE  
8. Asset Owner/Hub: THE SHELL PETROLEUM DEVELOPMENT COMPANY

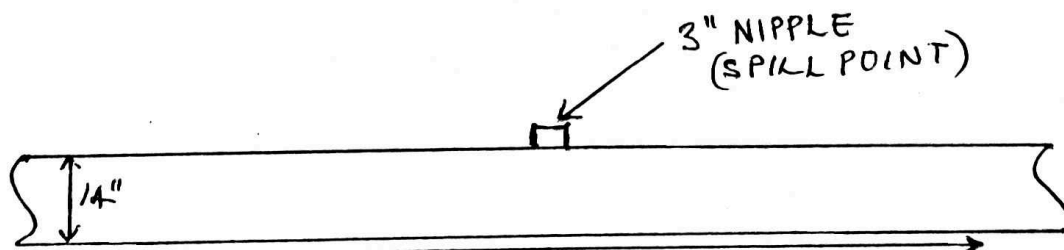
| <input checked="" type="checkbox"/> Crude oil theft (illegal bunkering) point, | <input type="checkbox"/> Saver-pit over flow | <input type="checkbox"/> Third party tampering with Clamp |

- ☒ Third party interference (Sabotage ☐; crude theft ☒; Line theft ☐; Accidental 3<sup>rd</sup> party damage ☐  
☐ Operational ☐ Others (including Mystery spills) \_\_\_\_\_

A SECTION OF 3" 14" OKORDIA - RUMUEKPE PIPELINE AT UKPELEDE SHOWING A 3" NIPPLE INSTALLED AT 12 O'CLOCK POSITION BY UNKNOWN PERSON(S).

SPILL CONTAINMENT / REPAIR BY CLAMPING
