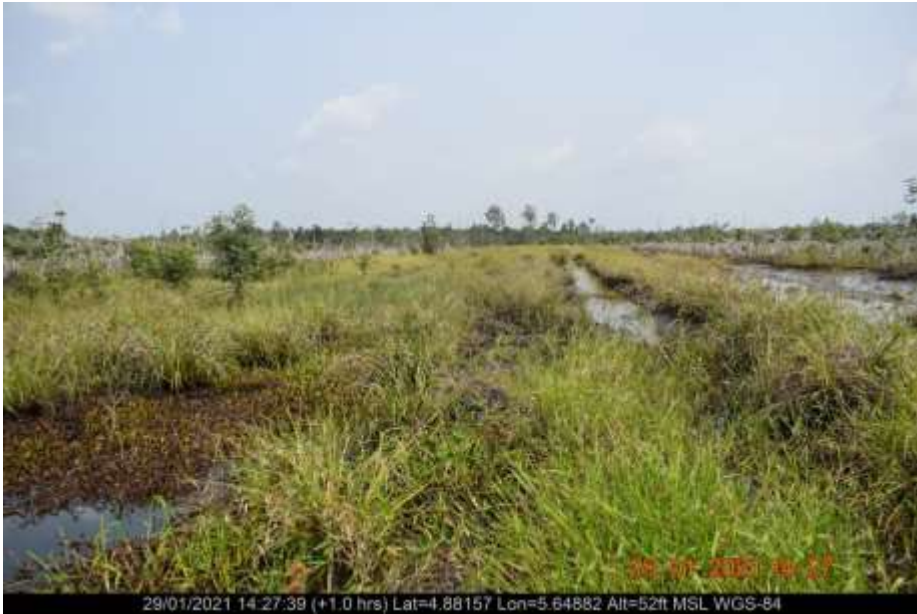
Overview: Part of spill impact on 6inch Kanbo Well 7s flowline at Agbidiama. Picture was taken during Joint Investigation of 29<sup>th</sup> January 2021.

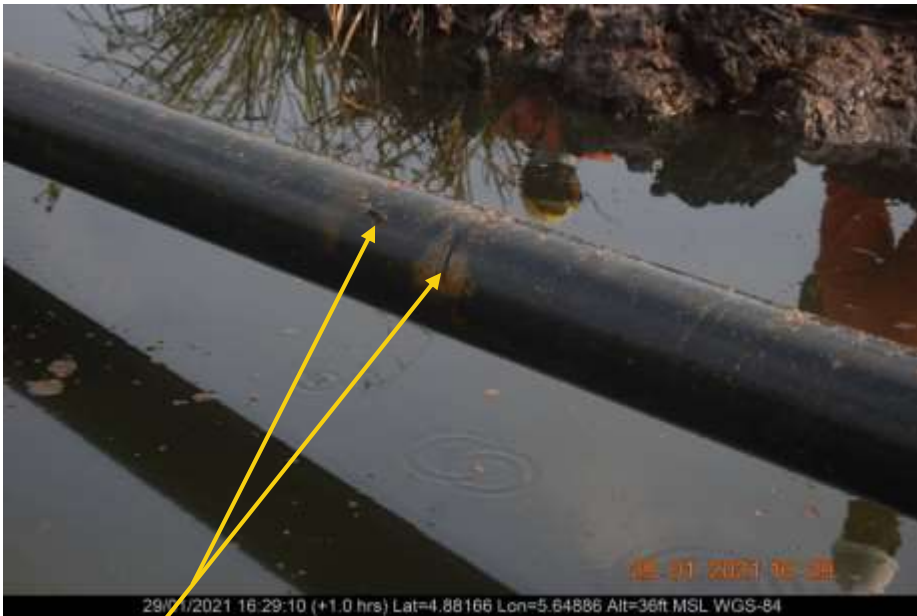
Close-up: 2 nos hacksaw cuts at 12 o'clock and 3 o'clock position on 6inch Kanbo Well 7s flowline at Agbidiama. Picture was taken during Joint Investigation of 29<sup>th</sup> January 2021.
