JOINT INVESTIGATION REPORT

INCIDENT NO: 2835247 JIV report S/N: 0709

1. Fountain Incident Number: 2835247 2. Type of incident* OIL SPILL
3. Name of Location 6" KANBO WELL 7S FLOWLINE
4. Name of nearest community AGBI DIAMAS 5. State: BAYELSA 6. LGA EKEREMO
7. Production Facility/Installation FLOW LINE
8. Asset Owner/Hub THE SHELL PETROLEUM DEVELOPMENT COMPANY NIGERIA LIMITED ITUNU NODE

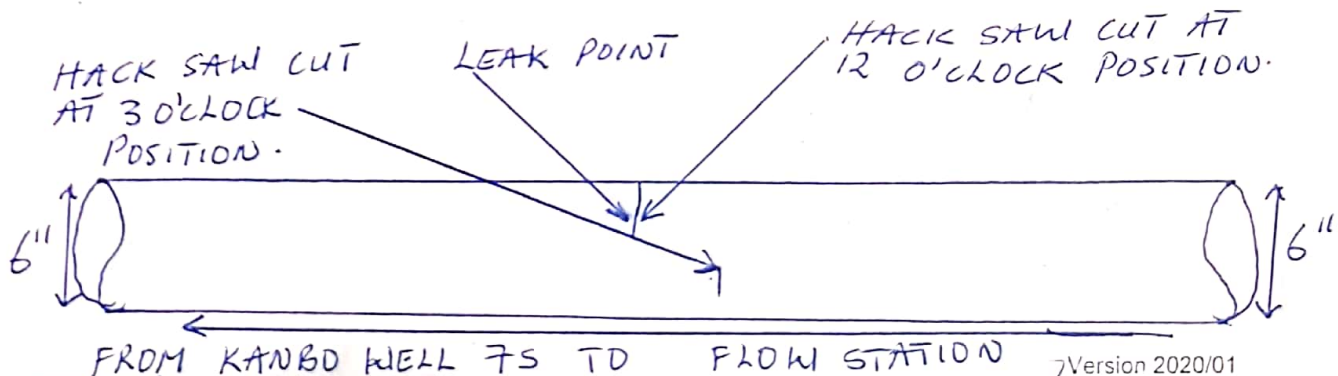
E. GRAPHIC DESCRIPTION OF LEAK POINT (while detailed description of the leak point should be contained in the leak report, overview sketch of the site should be added as appendix 1)

A SECTION OF 6" KANBO WELL 7S FLOWLINE AT AGBIDIAMA SHOWING 2 NO'S OF HACK SAW CUTS AT 12 O'CLOCK AND 3 O'CLOCK POSITION BY UNKNOWN PERSON.

REPAIR BY CLAMPING.
