INCIDENT NO: 2835839 JIV report S/N:

A. G	ENERAL INFORMATION:			
I. Fo	untain Incident Number: 283	583	9 2. Type of in	cident* DIL SPILL
	me of Location 28" BOM			
	me of nearest community FREE			
	eduction Facility/Installation			
100				CIRPORT COMPANY AT

B. IN	NIGERIA L CIDENT INFORMATION:	TD (S	POC) / PIPEL	ELEPMENT COMPANY OF
9. De a.	tails of incident Date Reported: 1874 JAN	UARY	2021	
	Start date/time of Investigation: 1 8			1330HRS
	Investigation End date: 197# J#			
	Description of spill point environme			
	□Firm soil	□Loose s	soil	Recently excavated area
	☐Under water	Swamp	y	□Exposed pipe surface
	Well Platform (on water)	Drill R		CISand bag(s)

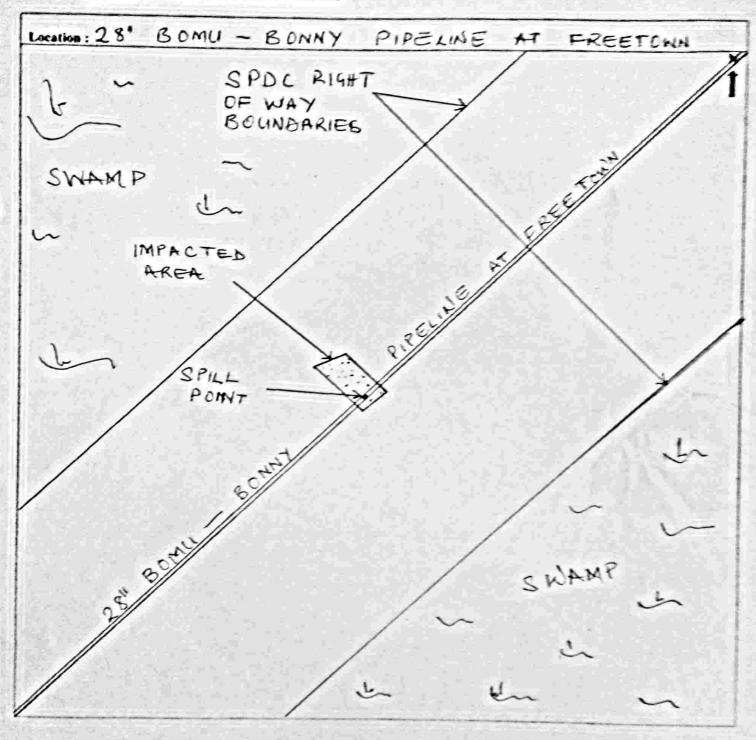
f. Appendix 1: Overview sketch of the site

20. Others (Specify) e.g. Animal Traps S/N Others Description Quantity/Size Commen	•
NONE WITHIN AREA OF IM	PACT
E. GRAPHIC DESCRIPTION OF LEAK POINT (while detailed description of the leak point he leak report, overview sketch of the site should be added as appendix 1) A SEC BOMU - BONNY PIPELINE AT FREETOWN 4 CRUDE OIL THEFT VALVE INSTALLED A	TION OF 28"
POSITION BY UNKNOWN PERSONS.	
4" VALVE LEAK POINT	
28" DECOATE AREA	
FROM BOMU TO BONNY
