JOINT INVESTIGATION REPORT

INCIDENT NO: 2843235 JIV report S/N:

1. Fountain Incident Number: 2843235 2. Type of incident* OIL SPILL
3. Name of Location 4" IMO RIVER 2-1 TEST LINE AND 2" IMO RIVER 1-2 GASLIFT LINE
4. Name of nearest community IGIRUKWO 5. State: ABIA 6. LGA UKWA WEST
7. Production Facility/Installation TEST LINE
8. Asset Owner/Hub THE SHELL PETROLEUM DEVELOPMENT COMPANY OF NIGERIA LIMITED (SPDC)

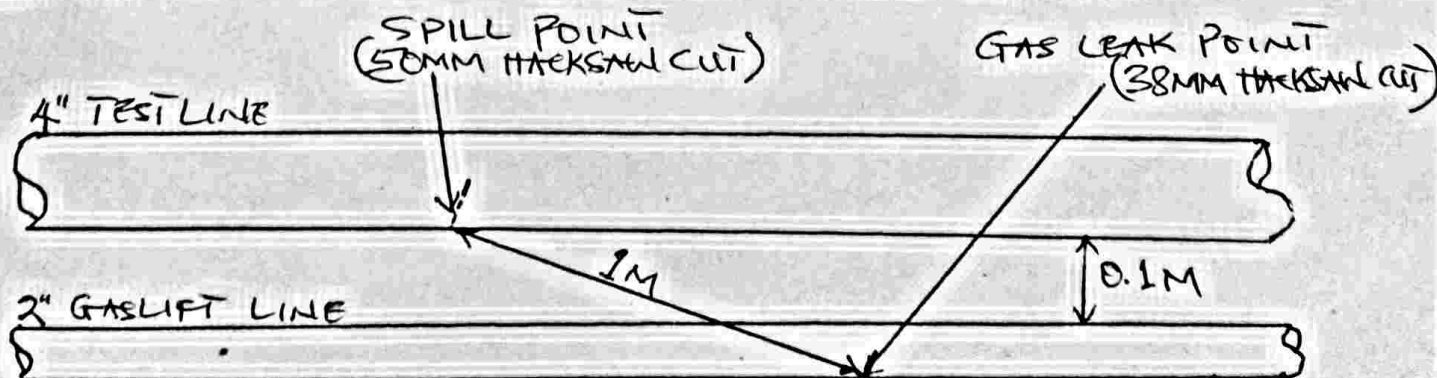
IMO RIVER 2 TO IMO RIVER 1

Additional observations around the spill point: THE JOINT INVESTIGATION TEAM OBSERVED A HACKSAW CUT (38MM LONG) AT 10-8 O'CLOCK POSITION ON THE 2" IMO RIVER 1-2 GASLIFT LINE PARALLEL TO THE 4" IMO RIVER 2-1 TEST LINE

E. GRAPHIC DESCRIPTION OF LEAK POINT (while detailed description of the leak point should be contained in the leak report, overview sketch of the site should be added as appendix 1) SECTIONS OF 4" IMO RIVER 2-1 TESTLINE AT IGIRUKWU SHOWING A HACKSAW CUT AT 10-7 O'CLOCK POSITION AND 2" IMO RIVER GASLIFT LINE SHOWING A HACKSAW CUT AT 10-8 O'CLOCK POSITION CAUSED BY UNKNOWN PERSONS

REPAIR BY CLAMPING ONGOING
