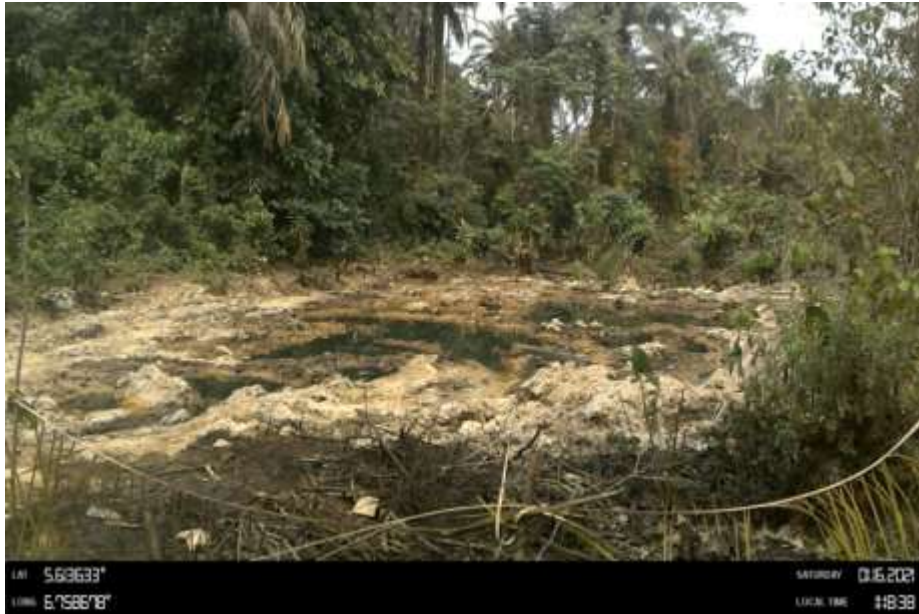
Overview: Part of spill impact on 12inch Oguta Egbema Pipeline at Opuoma . Picture was taken during Joint Investigation of 16th January 2021.

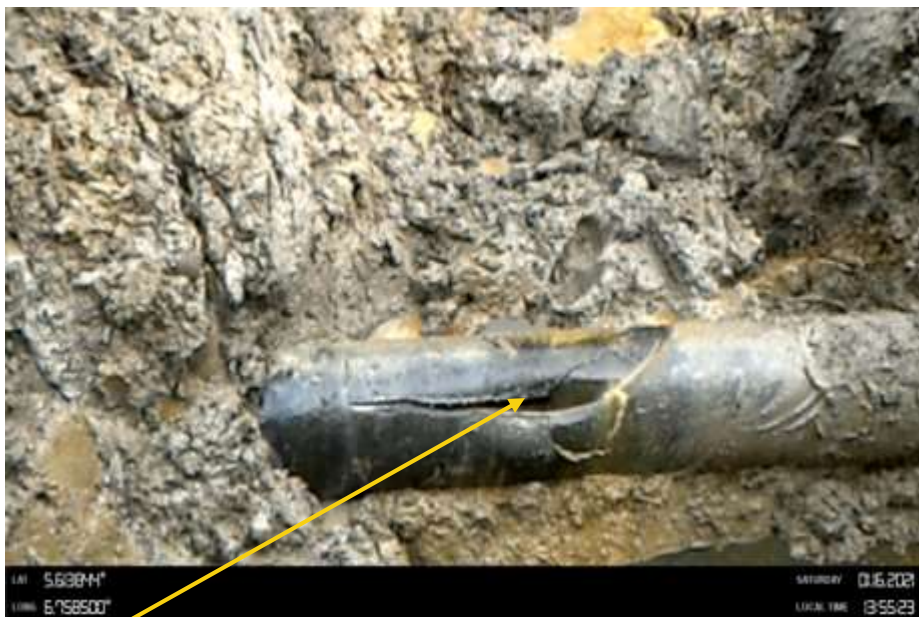
Close-up: Inward dent and crack at 1 o'clock position on 12inch Oguta Egbema Pipeline at Opuoma . Picture was taken during Joint Investigation of 16th January 2021.
