# JOINT INVESTIGATION REPORT

INCIDENT NO: 2840387 JIV report S/N:

1. Fountain Incident Number: 2840387 2. Type of incident\* OIL SPILL  
3. Name of Location 6" KANBO WELL 6T FLOW LINE  
4. Name of nearest community TUNU 5. State: BAYELSA 6. LGA EKEREMO  
7. Production Facility/Installation FLOW LINE  
8. Asset Owner/Hub THE SHELL PETROLEUM DEVELOPMENT COMPANY NIGERIA LIMITED / TUNU NODE

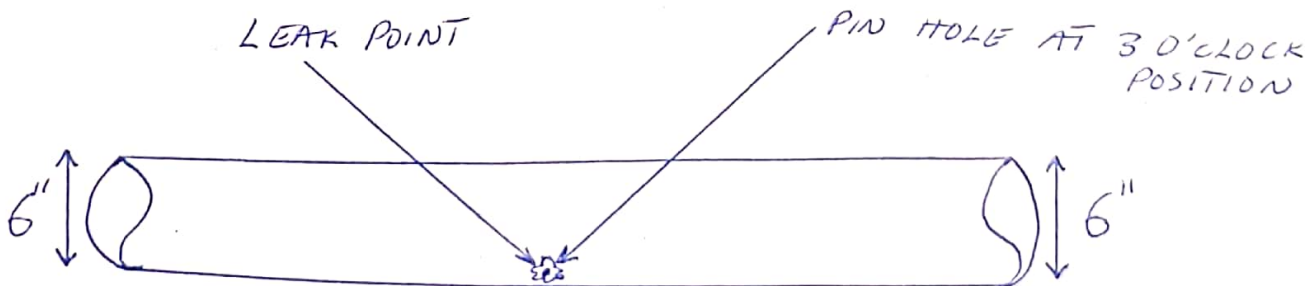
## E. GRAPHIC DESCRIPTION OF LEAK POINT (while detailed description of the leak point should be contained in the leak report, overview sketch of the site should be added as appendix 1)

| <input checked="" type="checkbox"/> Others (specify) <u>PIN HOLE DUE TO CORROSION</u> | | |

A SECTION OF 6" KANBO WELL 6T FLOWLINE AT TUNU SHOWING A PIN HOLE AT 3 O'CLOCK POSITION DUE TO CORROSION.

FROM KANBO WELL 6T TO FLOW STATION
