JOINT INVESTIGATION REPORT

INCIDENT NO: 2845130 JIV report S/N: 01103

A. GENERAL INFORMATION:

1. Fountain Incident Number: 2845130 2. Type of incident: OIL SPILL
3. Name of Location: 6" BELEMA DELIVERY LINE
4. Name of nearest community: BELEMA 5. State: RIVERS 6. LGA: AKUKU-TORU
7. Production Facility/Installation: OIL PIPELINE
8. Asset Owner/Hub: THE SHELL PETROLEUM DEVELOPMENT COMPANY OF NIGERIA LIMITED (SPDC)/CENTRAL HUB

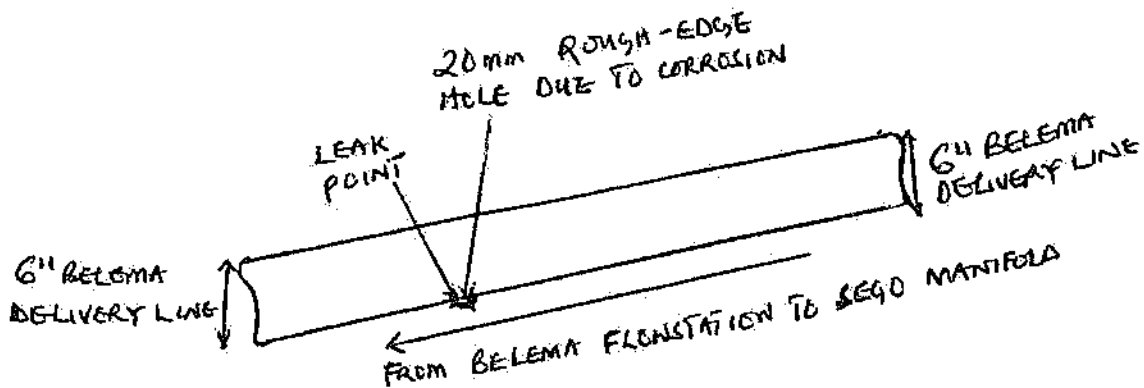
A SECTION OF 6" BELEMA DELIVERY LINE AT BELEMA SHOWING A 20mm ROUGH-EDGE HOLE DUE TO CORROSION AT 6 O'CLOCK POSITION.

REPAIR ACTIVITY ONGOING
