INCIDENT NO: 2992983 JIV report S/N:

A. GENERAL INFORMATION:		
1. Fountain Incident Number: 29929	2. Type of incid	lent* OIL SPILL
3. Name of Location 36" RUMUEK	PE - NKPOKU	PIDELINE
4. Name of nearest community 13AA		6. LGA EMOTTUA
	PIPELINE	O. LOA CT (OLTWA)
		JELERMENI GONZANY

8. Asset Owner/Hub HE SHELL PER OF NIGERIA LIN	AUTED (SPDO)	PIPELINE
		(, ,)
9. Details of incident a. Date Reported: 61H JULY, 203	21 ,	
b. Start date/time of Investigation: FIH J	ILY, 2021/1531	SONT

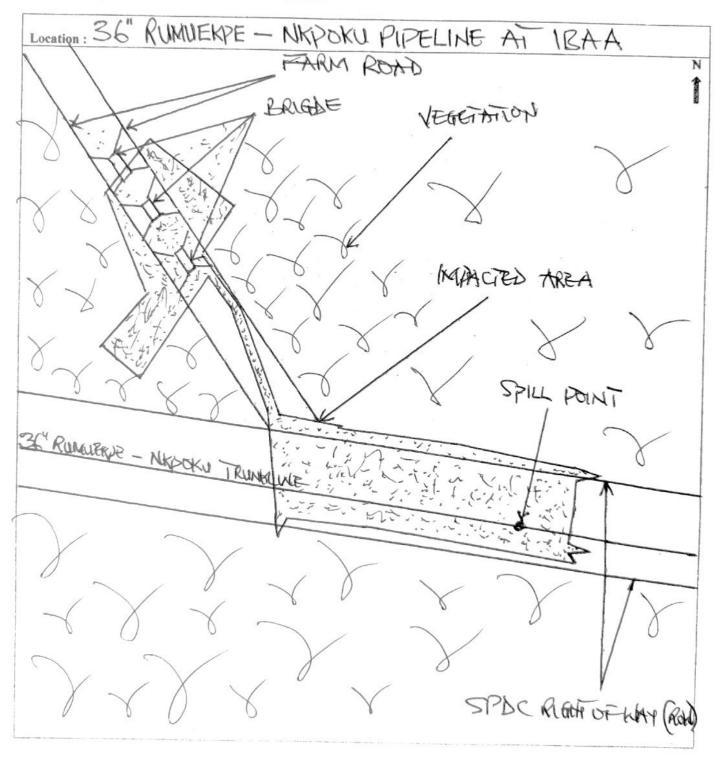
f. Appendix 1: Overview sketch of the site

E. GRAPHIC DESCRIPTION OF LEAK POINT (while detailed description of the leak point should be contained
in the leak report, overview sketch of the site should be added as appendix 1) A SECTION OF 36"
E ILLEGAL CONNECTION (IC) INSTALLED AT 15 0, COCK
POSITION BY UNKNOWN PERSON(S).
6" CRUDE THEFF POINT
(ILLEGAL COXINECTEN)
\[\frac{1}{36'} \]
FROM RUMUEKPE MANIFOLID — NKROKU MANUFOLD Version 2020/01 Distribution of copies: White (Asset Owner); Pink (DPR); Green (NOSDRA); Yellow (State Ministry of Environment);
Distribution of copies. White (Asset Owner); Pink (DPR); Green (NOSDRA); Yellow (State Ministry of Environment); Blue (Host Community) Page 3 of 8
