# JOINT INVESTIGATION REPORT

INCIDENT NO: 2984788 JIV report S/N: 0000791

1. Fountain Incident Number: 2984788 2. Type of incident\* OIL SPILL  
3. Name of Location 10" DIEBU CREEK - NUN RIVER PIPELINE  
4. Name of nearest community NANGI-AMA 5. State: BAYELSA 6. LGA SOUTHERN - IAW  
7. Production Facility/Installation OIL PIPELINE  
8. Asset Owner/Hub THE SHELL PETROLEUM DEVELOPMENT COMPANY OF NIGERIA LIMITED (SPDC) / PIPELINE

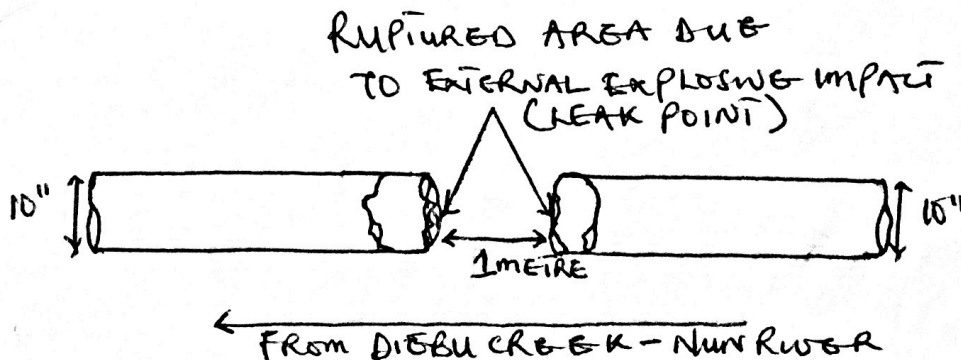
| <input checked="" type="checkbox"/> Others (specify) <u>EXPLOSIVE IMPACT</u> | | |

**E. GRAPHIC DESCRIPTION OF LEAK POINT** (while detailed description of the leak point should be contained in the leak report, overview sketch of the site should be added as appendix 1) A SECTION OF 10" DIEBU CREEK-NUN RIVER PIPELINE AT NANGIAMA SHOWING RUPTURED AREA DUE TO EXTERNAL EXPLOSIVE IMPACT DONE BY UNKNOWN PERSONS.
