# JOINT INVESTIGATION REPORT

INCIDENT NO: 2988133 JIV report S/N: 0000876

1. Fountain Incident Number: 2988133 2. Type of incident\* OIL SPILL  
3. Name of Location 4" IMO RIVER 2 WELL 2 IL FLOWLINE  
4. Name of nearest community ODAGWA 5. State: RIVERS 6. LGA ETCHE  
7. Production Facility/Installation FLOWLINE  
8. Asset Owner/Hub THE SHELL PETROLEUM DEVELOPMENT COMPANY OF NIGERIA LTD (SPDC) / LAND EAST HUB

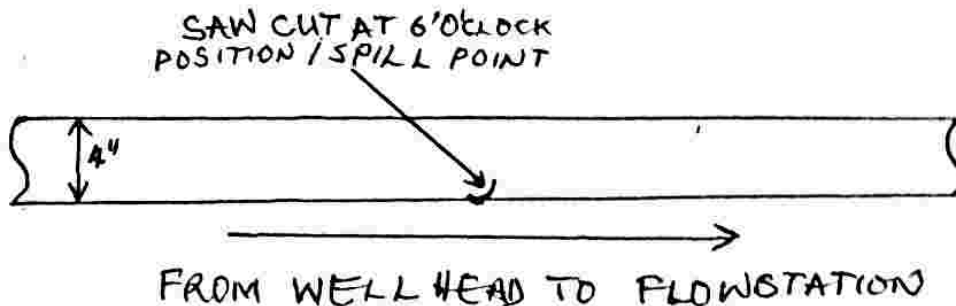
| <input type="checkbox"/> Smooth round-edge hole | <input type="checkbox"/> Rough-edge hole | <input checked="" type="checkbox"/> Hack saw cut |

- Third party interference (Sabotage  crude theft ; Line theft ; Accidental 3<sup>rd</sup> party damage   
 Operational  Others (including Mystery spills) \_\_\_\_\_

**E. GRAPHIC DESCRIPTION OF LEAK POINT** (while detailed description of the leak point should be contained in the leak report, overview sketch of the site should be added as appendix 1) A SECTION OF 4" IMD RIVER 2 WELL 21L FLOWING AT ODAGWA SHOWING A SAW CUT AT 6 O'CLOCK POSITION BY UNKNOWN PERSON(S).
