JOINT INVESTIGATION REPORT

INCIDENT NO: 3002415 JIV report S/N: 0000948

1. Fountain Incident Number: 3002415 2. Type of incident* OIL SPILL
3. Name of Location 16" NUN RIVER - KOLO CREEK TRUNKLINE
4. Name of nearest community ANGIAMAGBENE 5. State: BAYELSA 6. LGA SOUTHERN HAW
7. Production Facility/Installation OIL PIPELINE
8. Asset Owner/Hub THE SHELL PETROLEUM DEVELOPMENT COMPANY

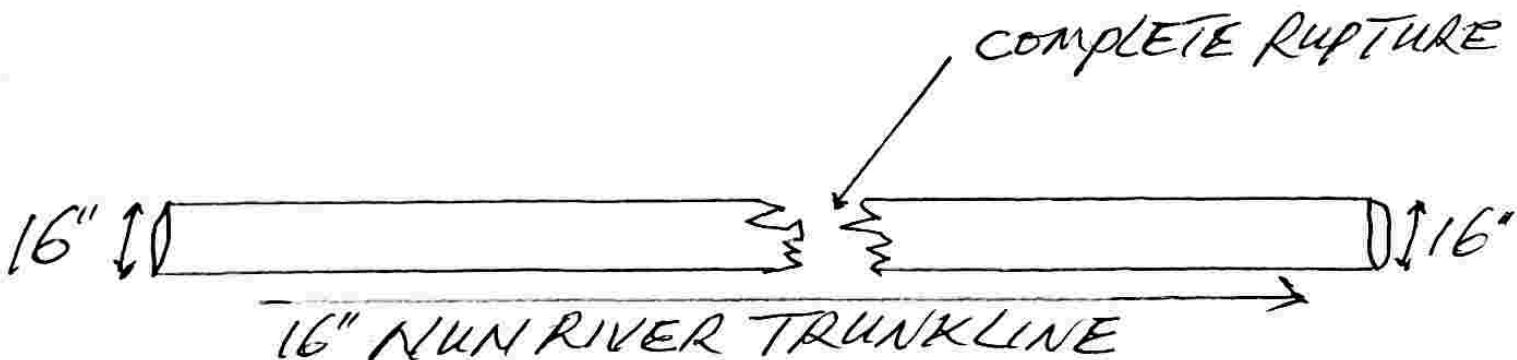
16" NUN-RIVER - KOLO-CREEK TRUNKLINE @ ANGIAMAGBENE
 INC.NO: 3002415 INC.DATE:30/072021

E. GRAPHIC DESCRIPTION OF LEAK POINT (while detailed description of the leak point should be contained in the leak report, overview sketch of the site should be added as appendix 1) A SECTION OF 16" NUN RIVER-KOLO CREEK TRUNKLINE AT ANGIAMAGBENE SHOWING COMPLETE RUPTURE BY SUSPECTED EXTERNAL IMPACT.
