JOINT INVESTIGATION REPORT

INCIDENT NO: 2997377 JIV report S/N: 000938

1. Fountain Incident Number 2997377 2. Type of incident* OIL SPILL
3. Name of Location 20" KOLO CREEK - RUMUEKPE TRUNKLINE
4. Name of nearest community OKOMA 5. State: RIVERS 6. LGA AKHADA EAST
7. Production Facility/Installation OIL PIPELINE
8. Asset Owner/Hub THE SHELL PETROLEUM DEVELOPMENT COMPANY

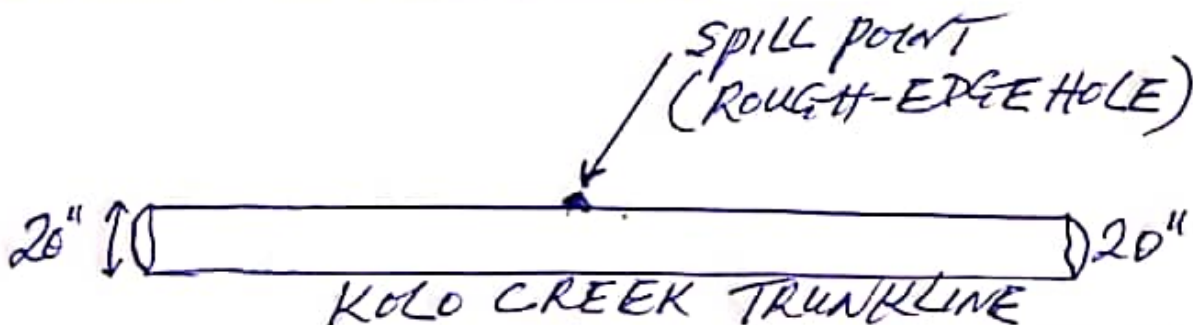
E. GRAPHIC DESCRIPTION OF LEAK POINT (while detailed description of the leak point should be contained in the leak report, overview sketch of the site should be added as appendix 1)

| <input type="checkbox"/> Smooth round-edge hole | <input checked="" type="checkbox"/> Rough-edge hole | <input type="checkbox"/> Hack saw cut |

A SECTION OF 20" KOLO CREEK - RUMUEKPE TRUNKLINE AT EKOMA SHOWING ROUGH-EDGE HOLE AT 12 O'CLOCK POSITION BY UNKNOWN PERSON(S)

REPAIR BY CLAMPING
