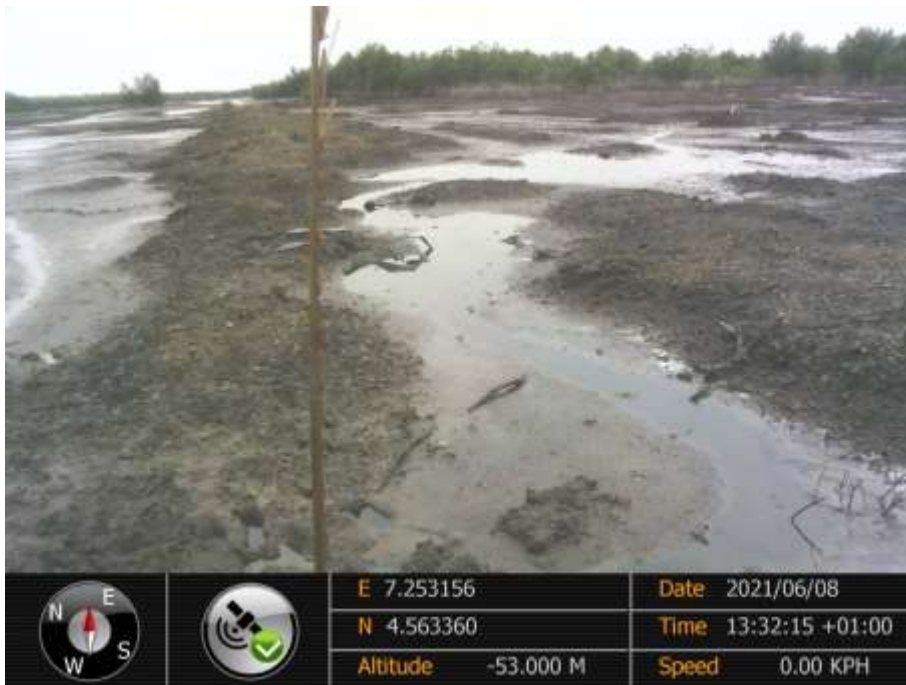
Overview: Part of spill impact on 24inch Bomu Bonny Trans Niger Pipeline at Owokiri.  
Picture was taken during Joint Investigation of 8<sup>th</sup> June 2021.

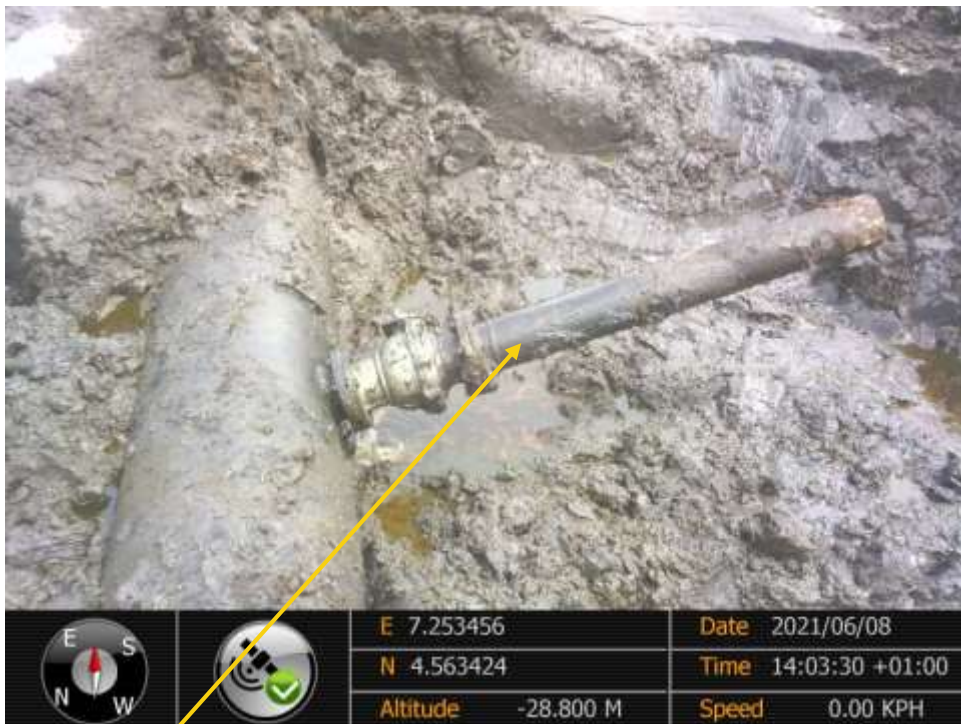
Close-up: 6inch valve flange leaking at the nipple flange installed at 3 o'clock position on 24inch Bomu Bonny Trans Niger Pipeline at Owokiri.  
Picture was taken during Joint Investigation of 8<sup>th</sup> June 2021.
