# JOINT INVESTIGATION REPORT

INCIDENT NO: 2966435 JIV report S/N: 0000790

1. Fountain Incident Number: 2966435 2. Type of incident\* OIL SPILL  
3. Name of Location 18" ASSA - RUMUERPPE PIPELINE  
4. Name of nearest community EGBEDA 5. State: RIVERS 6. LGA IMOHUA  
7. Production Facility/Installation OIL PIPELINE  
8. Asset Owner/Hub THE SHELL PETROLEUM DEVELOPMENT COMPANY OF NIGERIA LIMITED (SPDC)/PIPELINE

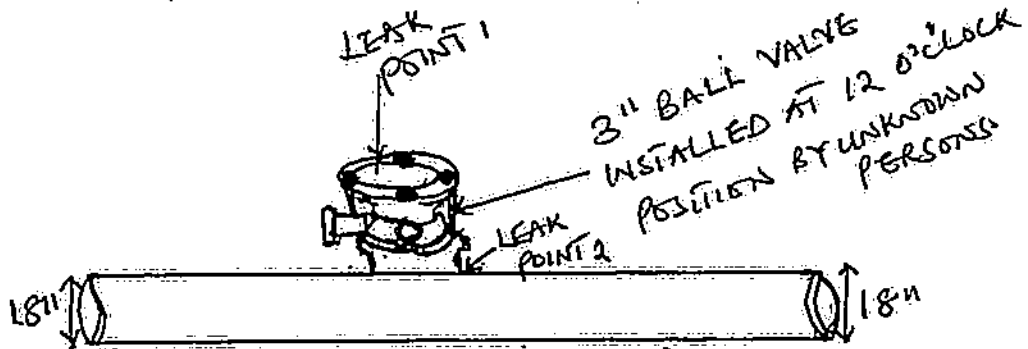
| <input checked="" type="checkbox"/> Failed Weld-on illegal hot tap valve | <input type="checkbox"/> Failed Clamp, | <input type="checkbox"/> Missing Pipeline/Flowline |
| <input checked="" type="checkbox"/> Crude oil theft (illegal bunkering) point, | <input type="checkbox"/> Saver-pit over flow | <input type="checkbox"/> Third party tampering with Clamp |

**E. GRAPHIC DESCRIPTION OF LEAK POINT** (while detailed description of the leak point should be contained in the leak report, overview sketch of the site should be added as appendix 1) A SECTION OF 18" ASSA-RUMYEKPE PIPELINE AT EGBEDA SHOWING A 3" BALL VALVE INSTALLED AT 12 O'CLOCK POSITION BY UNKNOWN PERSONS.
