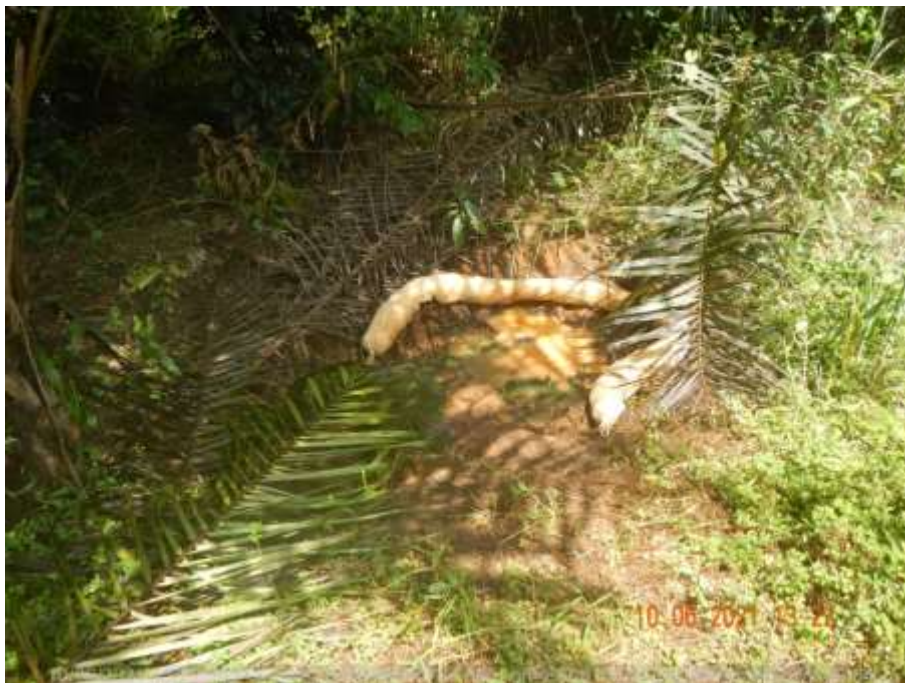
Overview: Part of spill impact on 4inch Mini Nta Well 2T Flowline at Elele Alimini. Picture was taken during Joint Investigation of 10th June 2021.

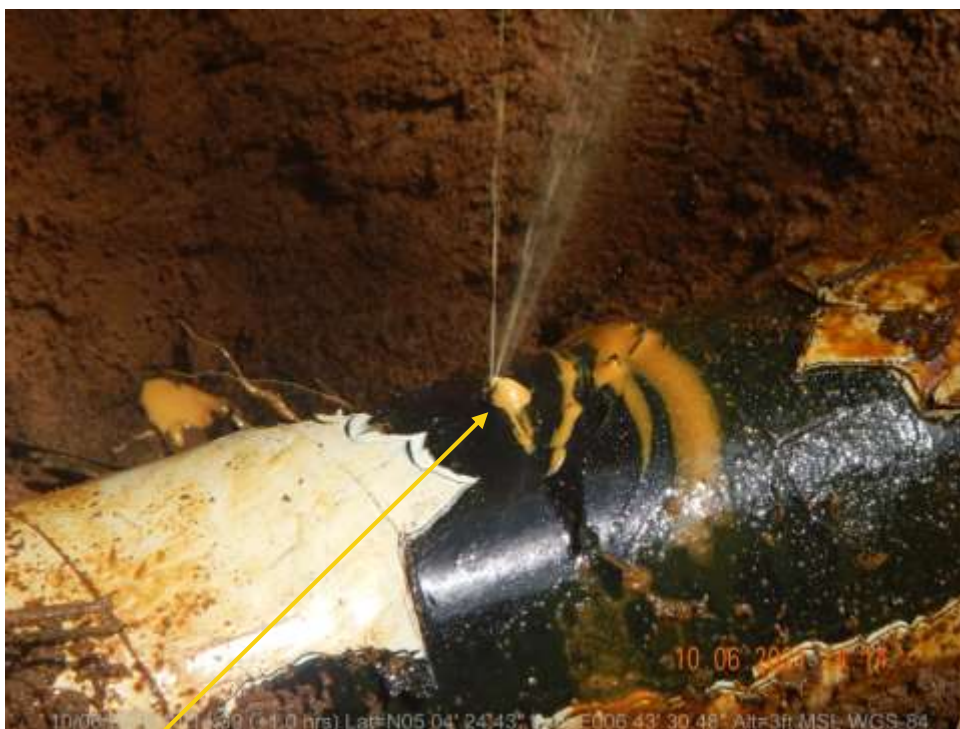
Close-up: 8cm Hacksaw cut at 11-12 o'clock position on 4inch Mini Nta Well 2T Flowline at Elele Alimini. White polythene tape was removed to allow inspection of the damage to the pipe and facilitate repair. Picture was taken during Joint Investigation of 10th June 2021
