# JOINT INVESTIGATION REPORT

INCIDENT NO: 2969706 JIV report S/N: 0000811

1. Fountain Incident Number: 2969706 2. Type of incident\* OIL SPILL  
3. Name of Location 24" TRANS ESCRAVOS PIPELINE  
4. Name of nearest community OBOTOBO 5. State: DELTA 6. LGA BURUTU  
7. Production Facility/Installation PIPELINE  
8. Asset Owner/Hub THE SHELL PETROLEUM DEVELOPMENT COMPANY NIGERIA LIMITED / PIPELINE.

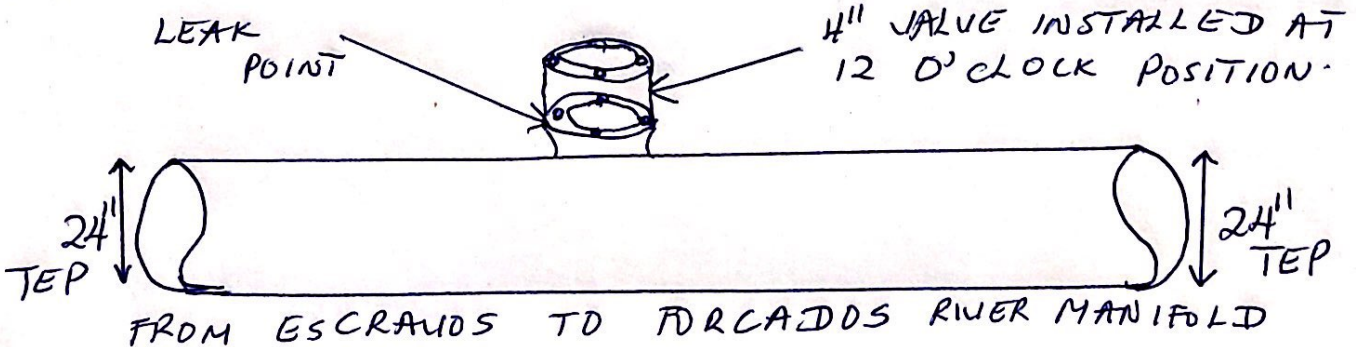
THE SPILL POINT WAS FOUND LEAKING DURING JUL. IT WAS A FORMERLY REPORTED NON LEAKING ILLEGAL CONNECTION WITH INCIDENT NO: 2708017

| <input checked="" type="checkbox"/> Crude oil theft (illegal bunkering) point, | <input type="checkbox"/> Saver-pit over flow | <input type="checkbox"/> Third party tampering with Clamp |

A SECTION OF 24" TRANS ESCRAUDS PIPELINE AT OBOTDA SHOWING WELD-ON 4" VALVE INSTALLED AT 12 O'CLOCK POSITION BY UNKNOWN PERSON(S).
