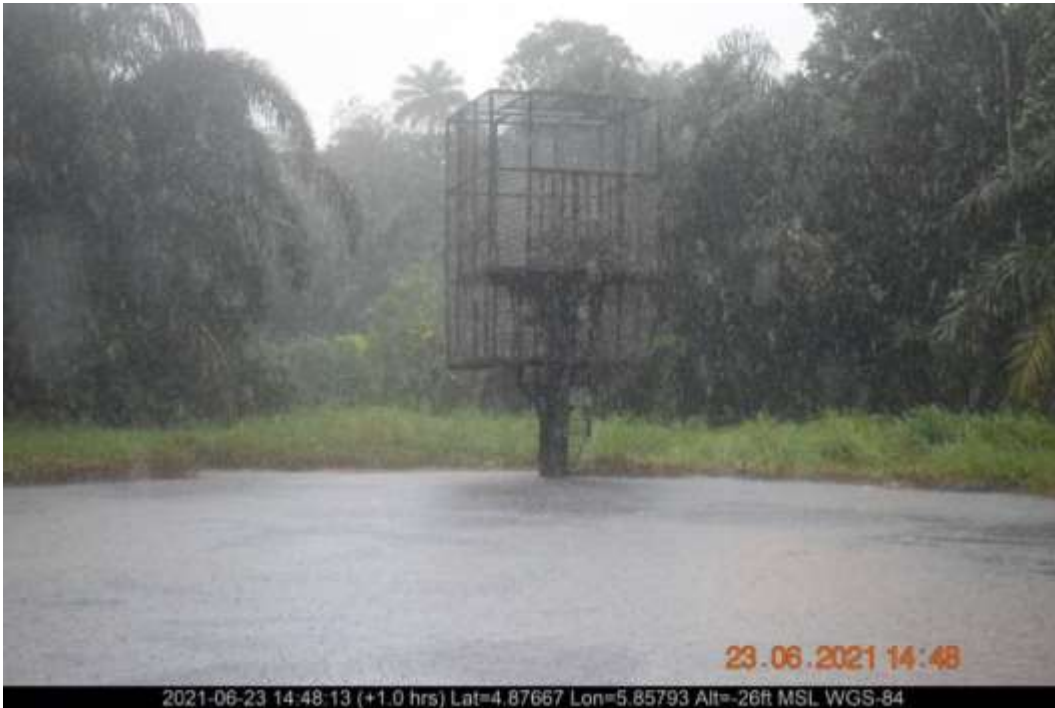
Overview: Part of spill impact on Ajatiton Well 1 Lima at Azagbene.
Picture was taken during Joint Investigation of 23rd June 2021.

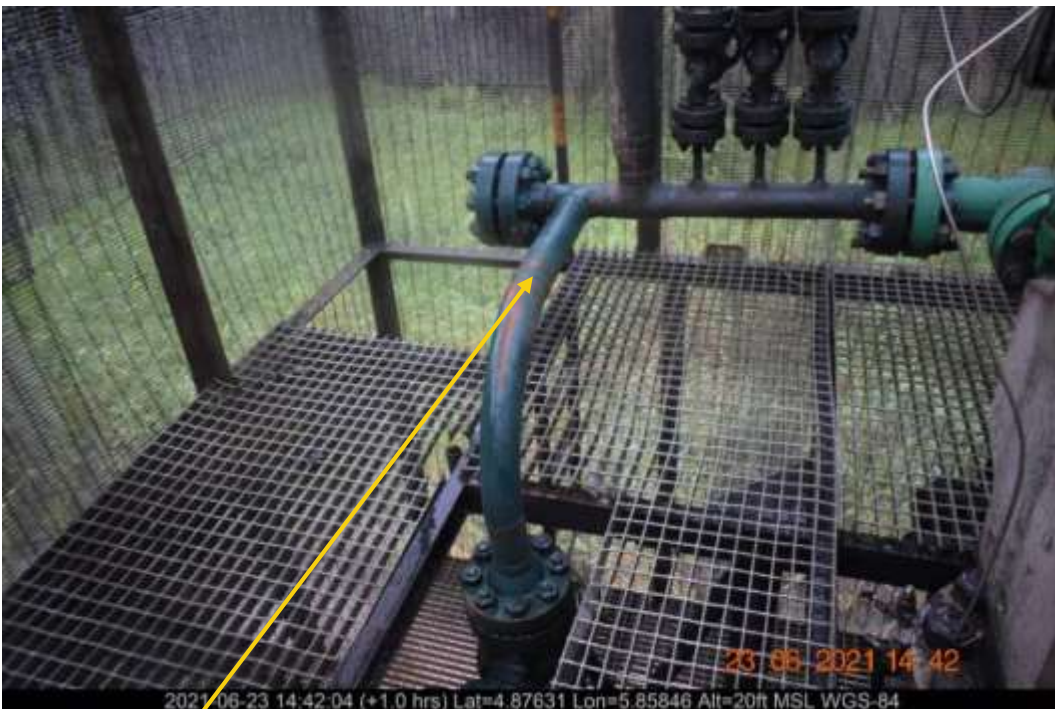
Close-up: Hacksaw cut at 12 o'clock position at hook up arm on Ajatiton Well 1 Lima at Azagbene.
Picture was taken during Joint Investigation of 23rd June 2021.
