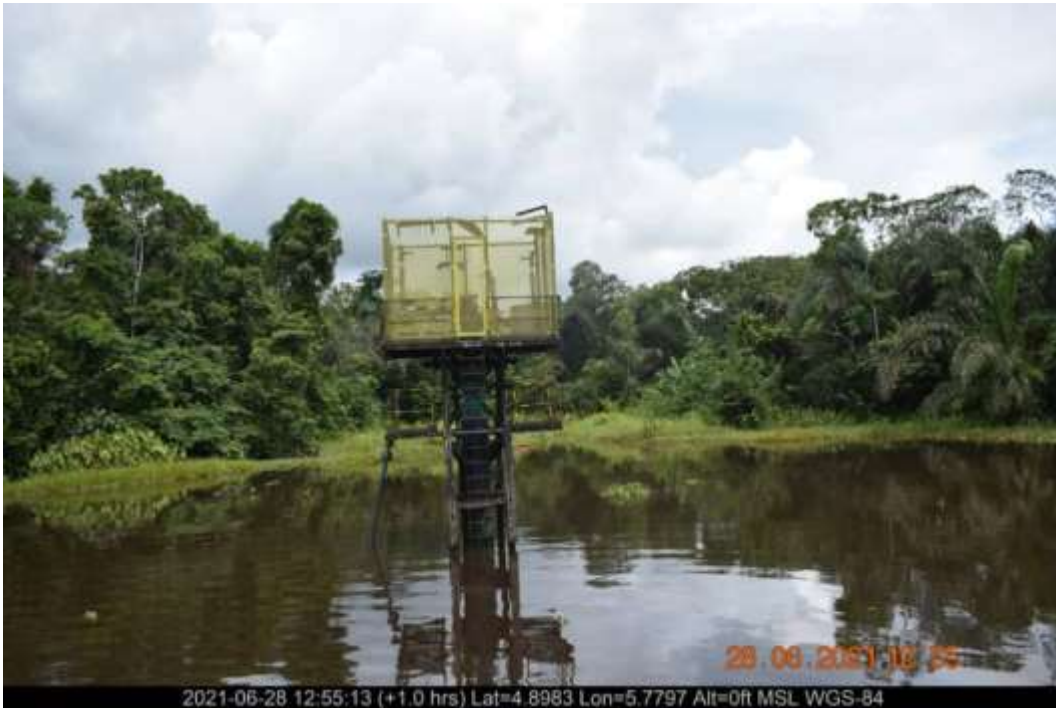
Overview: Part of spill impact on 3inch Opukushi Well 12 L/S Flowline at Agbidiana.  
Picture was taken during Joint Investigation of 28<sup>th</sup> June 2021.

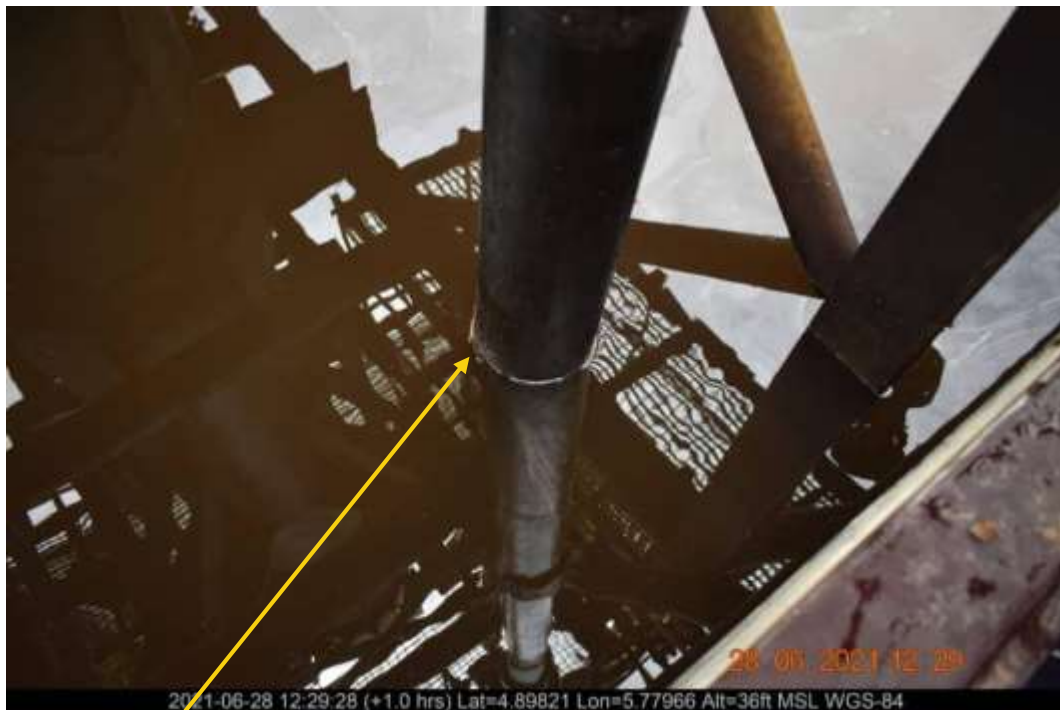
Close-up: Hacksaw cut at 12 o'clock position on 3inch Opukushi Well 12 L/S Flowline at Agbidiana.  
Picture was taken during Joint Investigation of 28<sup>th</sup> June 2021.
