JOINT INVESTIGATION REPORT

INCIDENT NO: 2974064 JIV report S/N: 0663

1. Fountain Incident Number: 2974064 2. Type of incident* OIL SPILL
3. Name of Location ³¹¹ OPUKUSHI WELL 12 LIS FLOW LINE
4. Name of nearest community AGBIDIAMA 5. State: BAYELSA 6. LGA EKEREMO
7. Production Facility/Installation FLOW LINE
8. Asset Owner/Hub THE SHELL PETROLEUM DEVELOPMENT COMPANY NIGERIA LIMITED (SWAMP WEST)

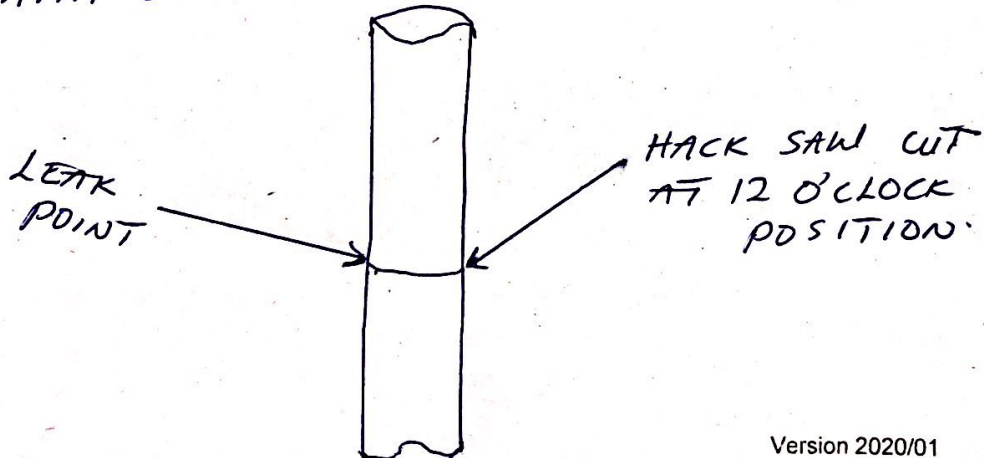
| <input type="checkbox"/> Smooth round-edge hole | <input type="checkbox"/> Rough-edge hole | <input checked="" type="checkbox"/> Hack saw cut |

- Third party interference (Sabotage ; crude theft ; Line theft ; Accidental 3rd party damage
 Operational Others (including Mystery spills) _____

A SECTION OF 3" OPUKUSTI WELL 12 LIS FLOWLINE AT AGBIDIAMA SHOWING HACK SAW CUT AT 12 O'CLOCK POSITION.
