JOINT INVESTIGATION REPORT

INCIDENT NO: 2970146 JIV report S/N: 0000814

1. Fountain Incident Number: 2970146 2. Type of incident* OIL SPILL
3. Name of Location ASATITON WELL 1 LIMA FLOWLINE
OPUKUSHI
4. Name of nearest community AZAGBERE 5. State: BAVELSA 6. LGA SOUTHERN IJAW
7. Production Facility/Installation FLOWLINE
8. Asset Owner/Hub THE SHELL PETROLEUM DEVELOPMENT COMPANY NIGERIA LIMITED / SWAMP WEST

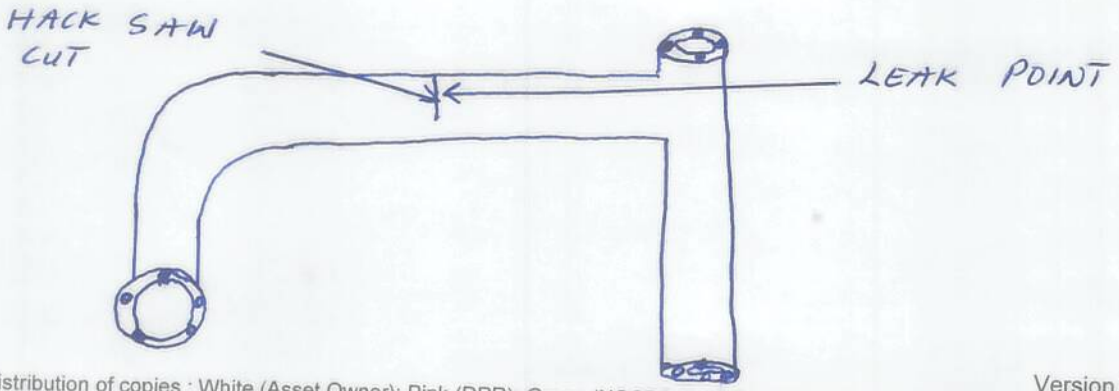
| <input type="checkbox"/> Smooth round-edge hole | <input type="checkbox"/> Rough-edge hole | <input checked="" type="checkbox"/> Hack saw cut |

- Third party interference (Sabotage ; crude theft ; Line theft ; Accidental 3rd party damage
 Operational Others (including Mystery spills) _____

A SECTION OF AJATITON WELL 1 LIMA FLOWLINE AT OPUKUSHI SHOWING HACK SAW CUT AT 12 O'CLOCK POSITION AT HOOK UP ARM.
