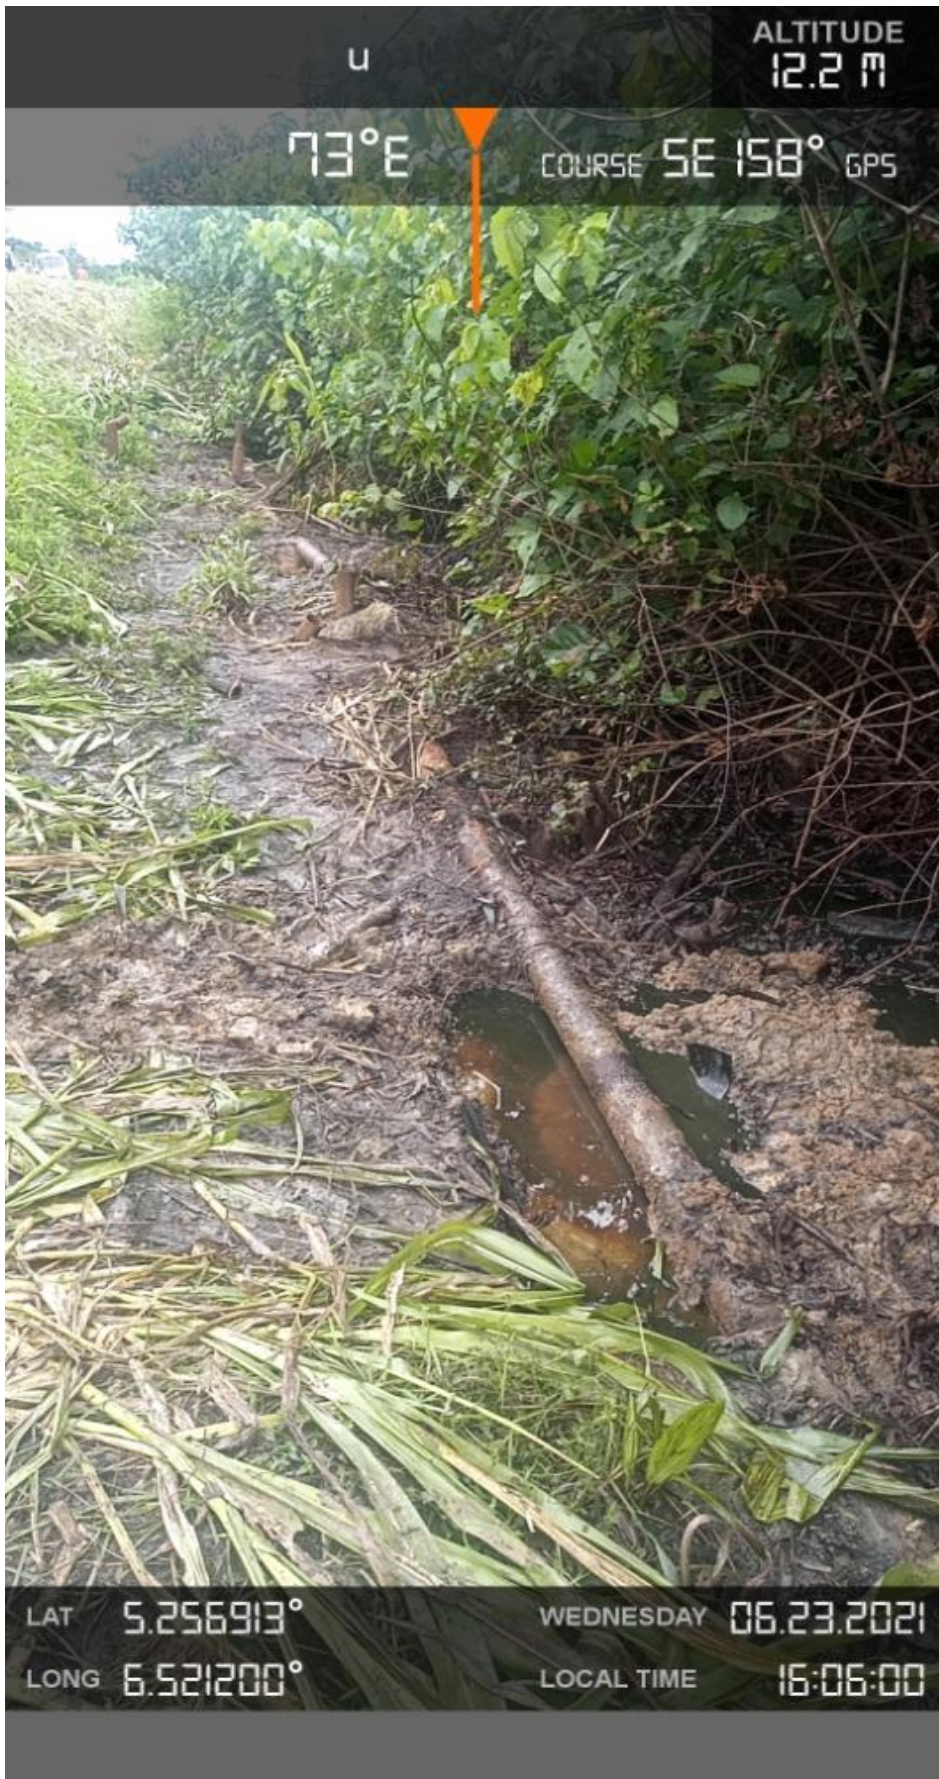
Overview: Part of spill impact on Adibawa North East Well 1 Flowline at Biseni.
Picture was taken during Joint Investigation of 23rd June 2021.

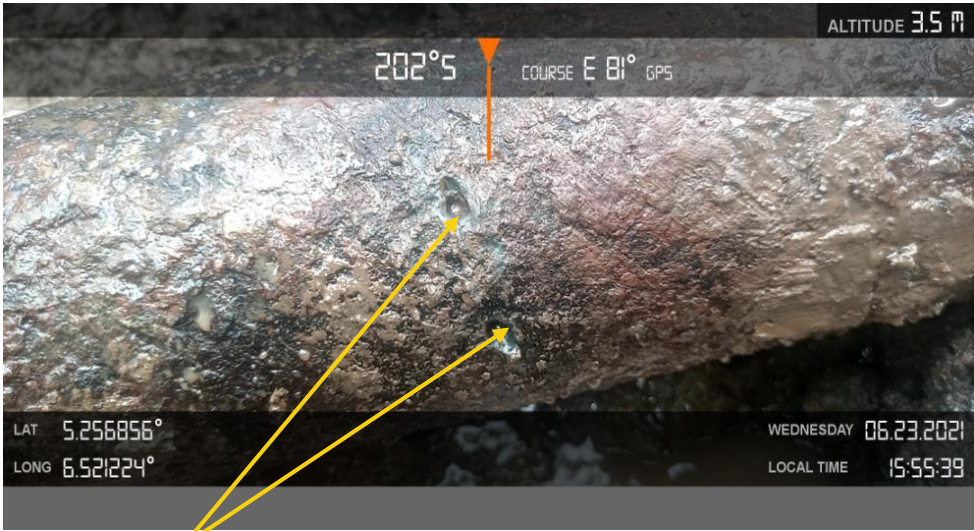
Closeup 1: One of three nos spill points puncture on Adibawa North East Well 1 Flowline at Biseni. Picture was taken during Joint Investigation of 23rd June 2021.

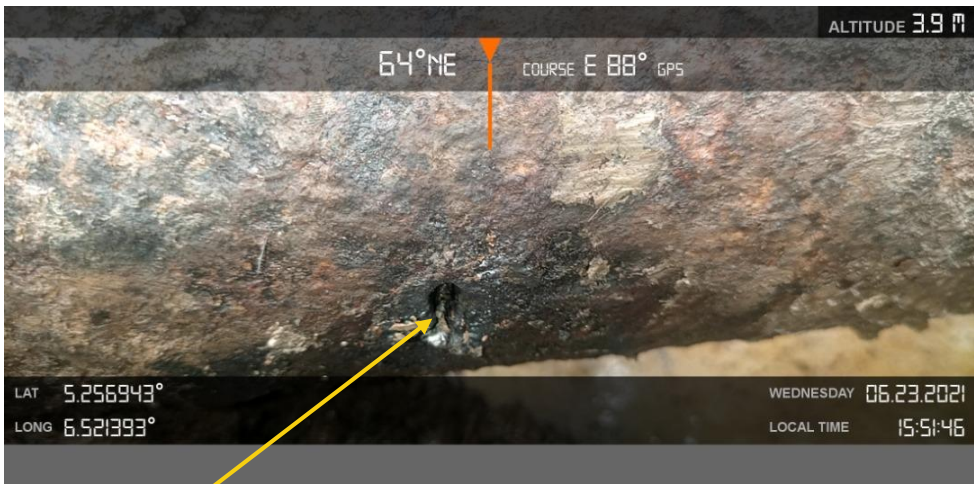
Closeup 2: Two of three nos spill points puncture on Adibawa North East Well 1 Flowline at Biseni. Picture was taken during Joint Investigation of 23rd June 2021.

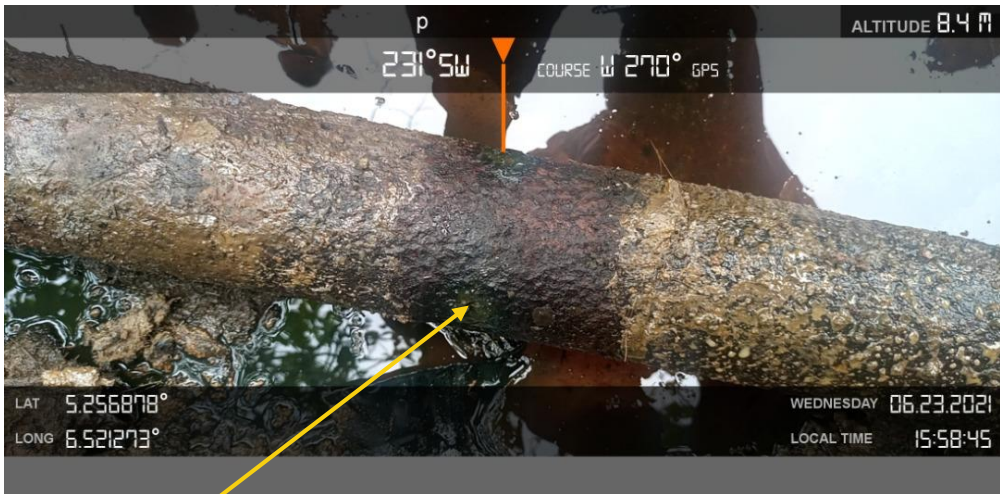
Closeup 3: Three of Three nos spill points puncture on Adibawa North East Well 1 Flowline at Biseni. Picture was taken during Joint Investigation of 23rd June 2021.
