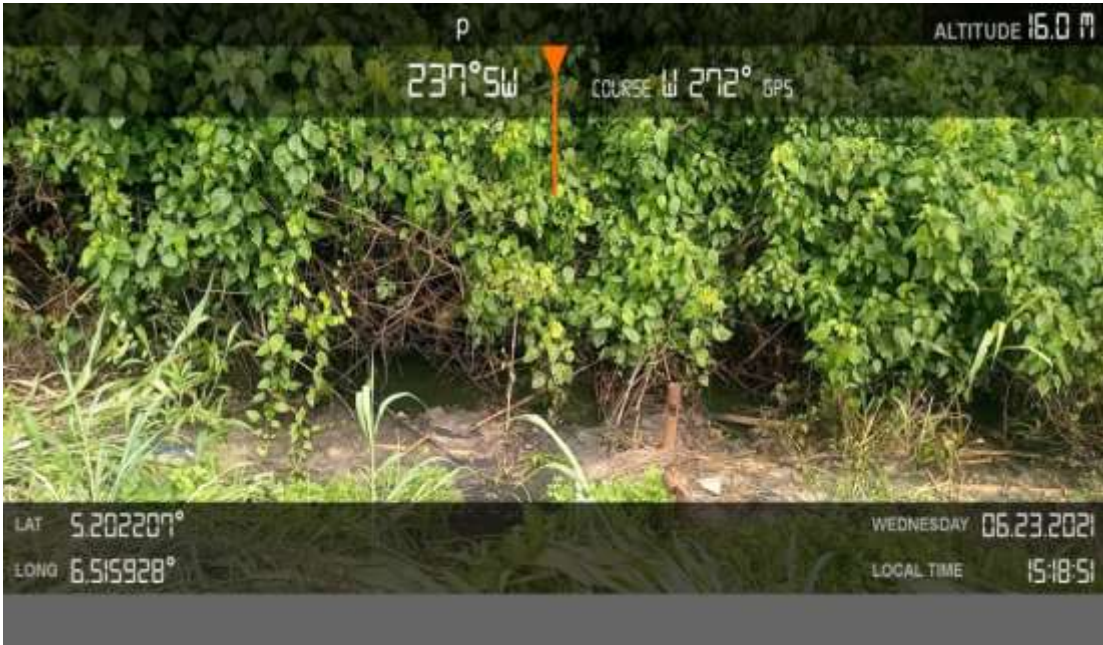
Overview: Part of spill impact on Adibawa Well 10s flowline at Edagberi.  
Picture was taken during Joint Investigation of 23<sup>rd</sup> June 2021.

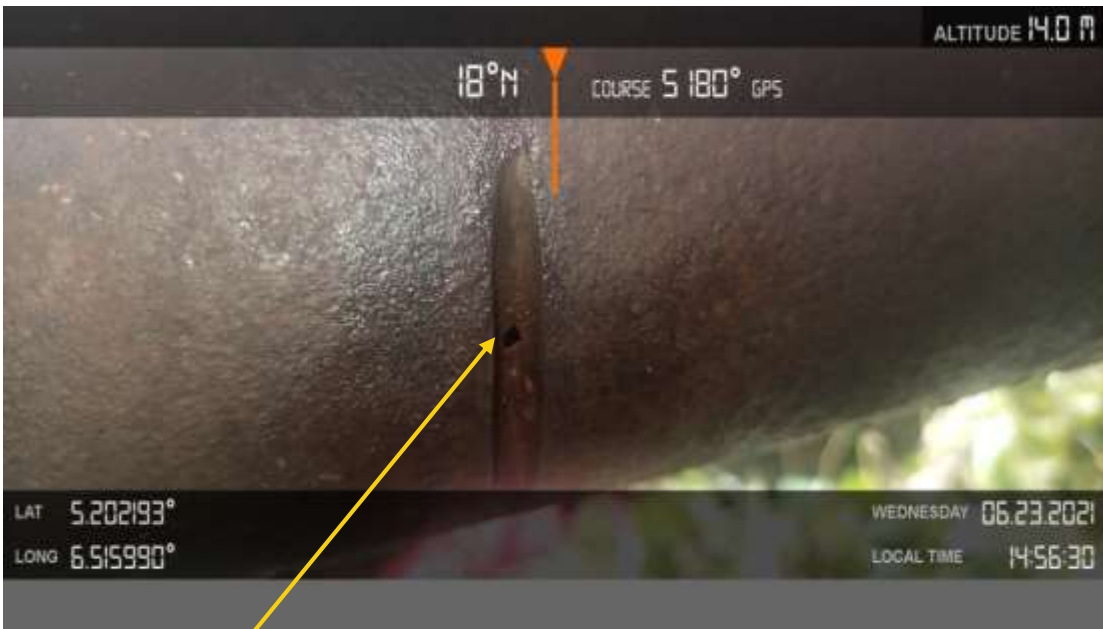
Close-up: Hacksaw at 5 o'clock position on Adibawa Well 10s flowline at Edagberi.  
Picture was taken during Joint Investigation of 23<sup>rd</sup> June 2021.
