JOINT INVESTIGATION REPORT

INCIDENT NO: 2974931 JIV report S/N: 0000884

1. Fountain Incident Number: 2974931 2. Type of incident* OIL SPILL
3. Name of Location ADIBAWA WELL 10S FLOWLINE
4. Name of nearest community ESAGBERI 5. State: RIVERS 6. LGA AHOADA WEST
7. Production Facility/Installation FLOWLINE
8. Asset Owner/Hub THE SHELL PETROLEUM DEVELOPMENT COMPANY OF NIGERIA LIMITED (SPDC) / CENTRAL HUB

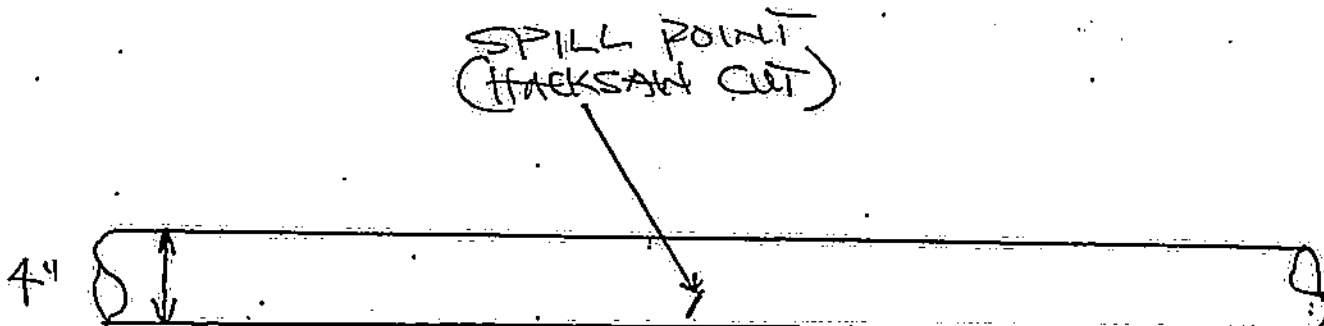
| <input type="checkbox"/> Smooth round-edge hole | <input type="checkbox"/> Rough-edge hole | <input checked="" type="checkbox"/> Hack saw cut |

- Third party interference (Sabotage ; crude theft ; Line theft ; Accidental 3rd party damage
 Operational Others (including Mystery spills) _____

E. GRAPHIC DESCRIPTION OF LEAK POINT (while detailed description of the leak point should be contained in the leak report, overview sketch of the site should be added as appendix 1) A SECTION OF ADIBAWA WELL 10S FLOWLINE AT EDAGBERI SHOWING A HACKSAW CUT AT 5 O'CLOCK POSITION BY UNKNOWN PERSONS

REPAIR IS ONGOING
