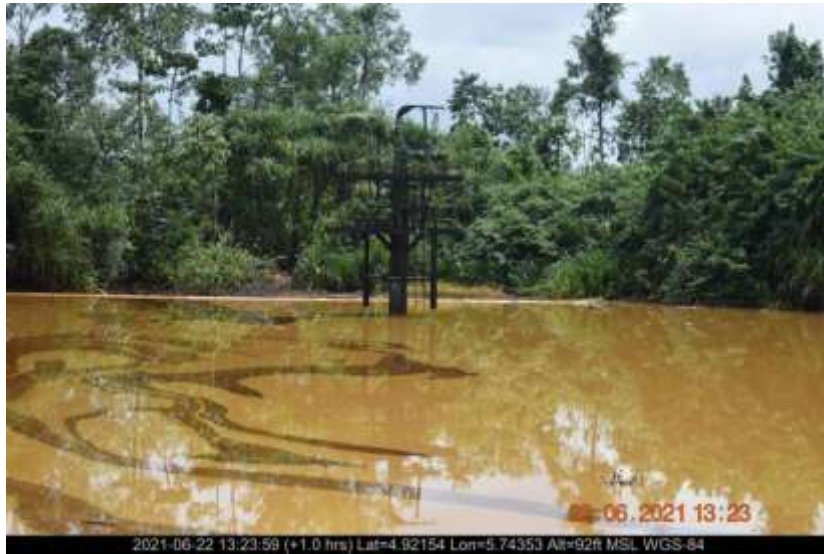
Overview: Part of spill impact on Opukushi Well 24T Wellhead at Agbidiana.  
Picture was taken during Joint Investigation of 22<sup>nd</sup> June 2021.

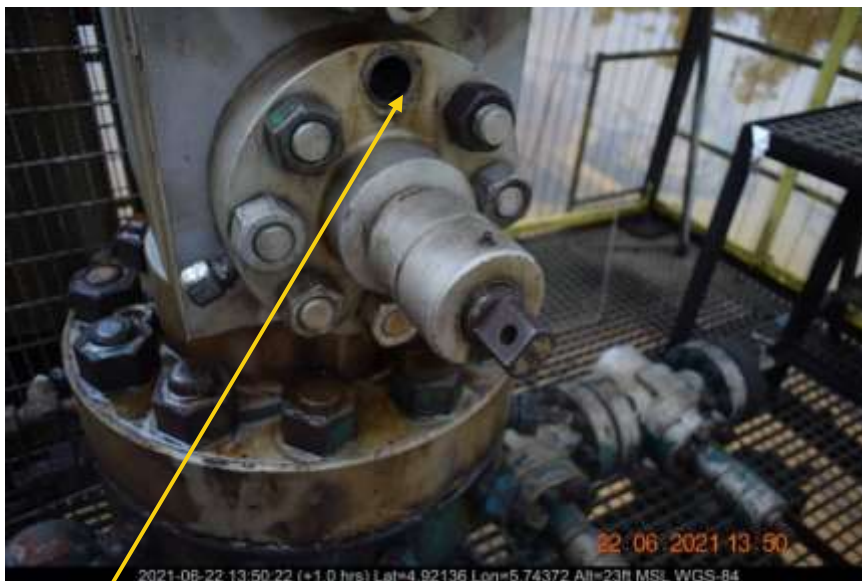
Close-up: Tampered valve on Opukushi Well 24T Wellhead at Agbidiana.  
Picture was taken during Joint Investigation of 22<sup>nd</sup> June 2021.
