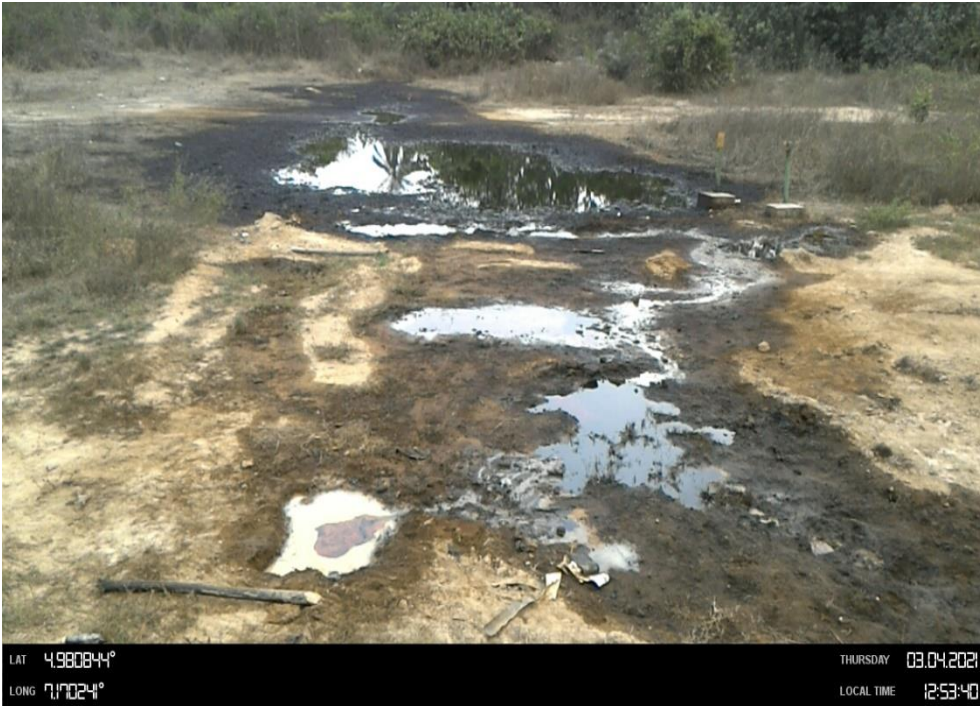
Overview: Part of spill impact on 12inch Imo River2 – Imo River1 Pipeline at Odagwa. Picture was taken during Joint Investigation of 4th March 2021.

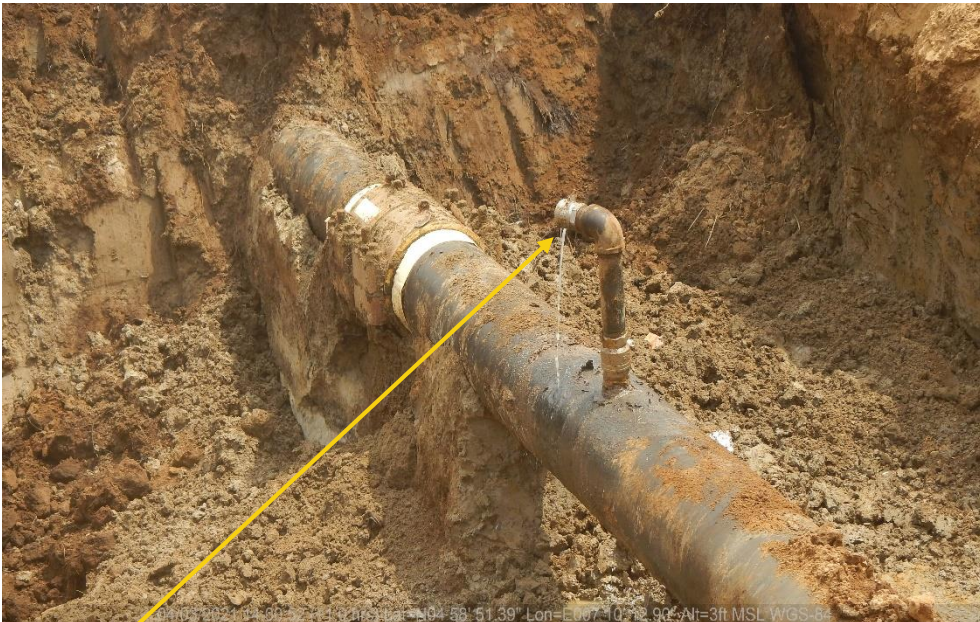
Close-up: Crude oil theft point installed at 12 o'clock position on 12inch Imo River2 – Imo River1 Pipeline at Odagwa. Picture was taken during Joint Investigation of 4th March 2021.
