JOINT INVESTIGATION REPORT

INCIDENT NO: 2878261 JIV report S/N: 0000779

1. Fountain Incident Number: 2878261 2. Type of incident* OIL SPILL
3. Name of Location 12" IMORIVER 2 - IMORIVER PIPELINE
4. Name of nearest community ODAGWA 5. State: ABIA 6. LGA ETCITE
7. Production Facility/Installation CRUDE OIL PIPELINE
8. Asset Owner/Hub THE SHELL PETROLEUM DEVELOPMENT COMPANY
OF NIGRIA LIMITED / PIPELINE

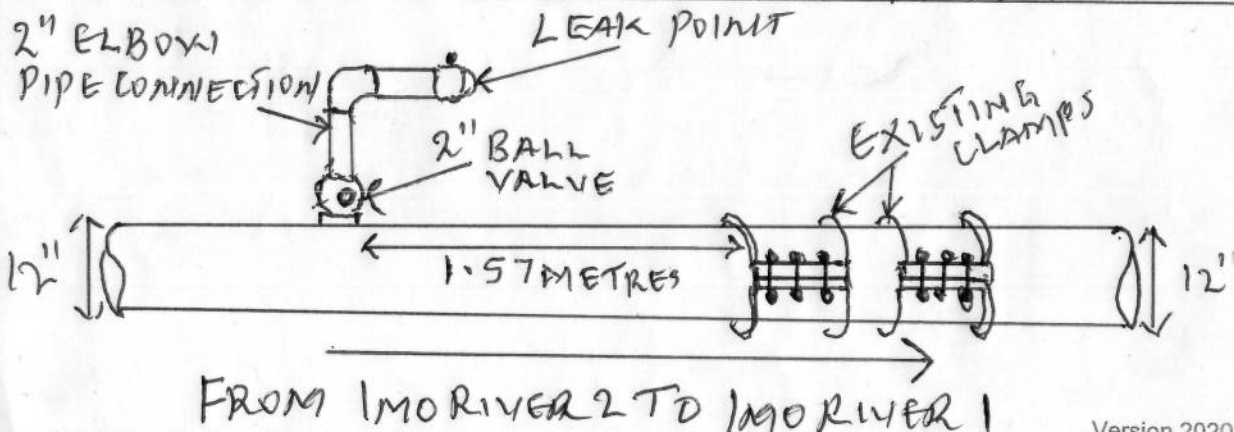
| <input checked="" type="checkbox"/> Failed Weld-on illegal hot tap valve | <input type="checkbox"/> Failed Clamp, | <input type="checkbox"/> Missing Pipeline/Flowline |
| <input checked="" type="checkbox"/> Crude oil theft (illegal bunkering) point, | <input type="checkbox"/> Saver-pit over flow | <input type="checkbox"/> Third party tampering with Clamp |

- ☒ Third party interference (Sabotage ☐; crude theft ☒; Line theft ☐; Accidental 3rd party damage ☐
☐ Operational ☐ Others (including Mystery spills) _____

SECTION OF 12" IMORIVER 2 - IMORIVER 1 PIPELINE AT ODAGWA SHOWING CRUDE OIL THEFT POINT INSTALLED AT 12 O'CLOCK POSITION BY UNKNOWN PERSONS.

CRUDE OIL RECOVERY AND REPAIR ACTIVITIES ARE ONGOING.
