JOINT INVESTIGATION REPORT

INCIDENT NO: 2881489 JIV report S/N: 0000802

1. Fountain Incident Number: 2881489 2. Type of incident* OIL SPILL
3. Name of Location 6" SEIBUO WELL 3 & 4 BULKLINE
4. Name of nearest community OGBEINBIRI 5. State: BAYELSA 6. LGA EKEREMO
7. Production Facility/Installation BULKLINE
8. Asset Owner/Hub THE SHELL PETROLEUM DEVELOPMENT COMPANY NIGERIA LIMITED / SWAMP WEST.

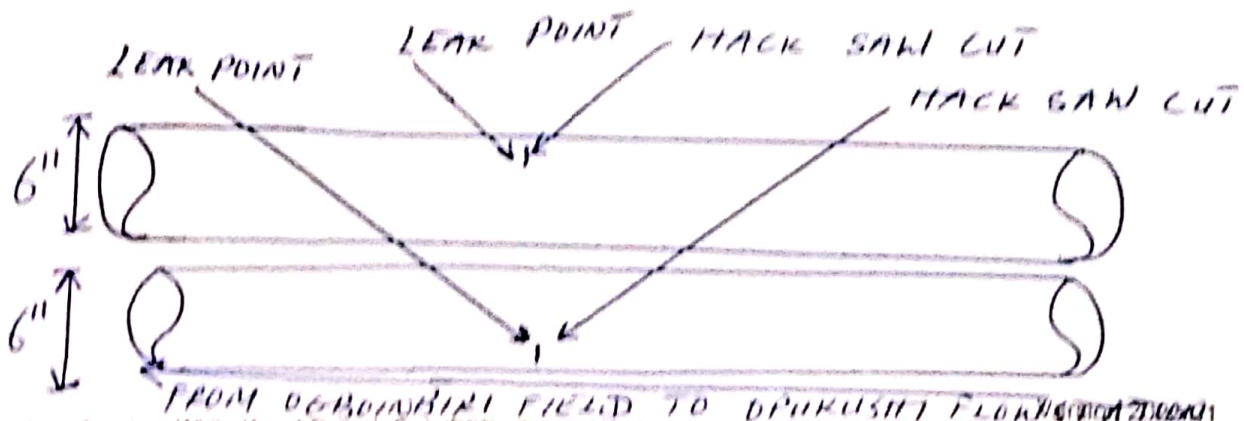
E. GRAPHIC DESCRIPTION OF LEAK POINT (while detailed description of the leak point should be contained in the leak report, overview sketch of the site should be added as appendix 1)

f. Incident caused by:

- ☒ Third party interference (Sabotage ☒ crude theft ☐; Line theft ☐; Accidental 3rd party damage ☐
☐ Operational ☐ Others (including Mystery spills) _____

A SECTION OF 6" SEIBUD WELL 3 & 4 BULKLINE AT OGBONIBIR SHOWING 2 NO'S HACK SAW CUTS AT 3 O'CLOCK AND 9 O'CLOCK POSITIONS ON EACH LINE BY UNKNOWN PERSON(S).
