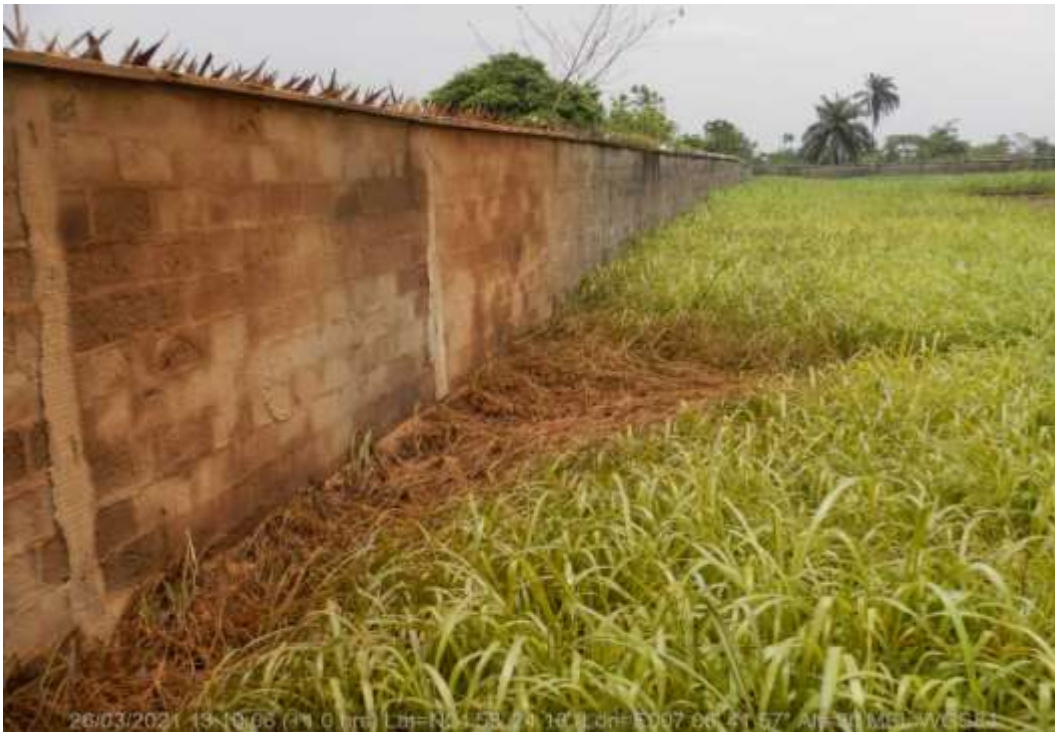
Overview: Part of spill impact on 4inch Nkali well 13L/S flowline at Odagwa 2.
Picture was taken during Joint Investigation of 26th March 2021.

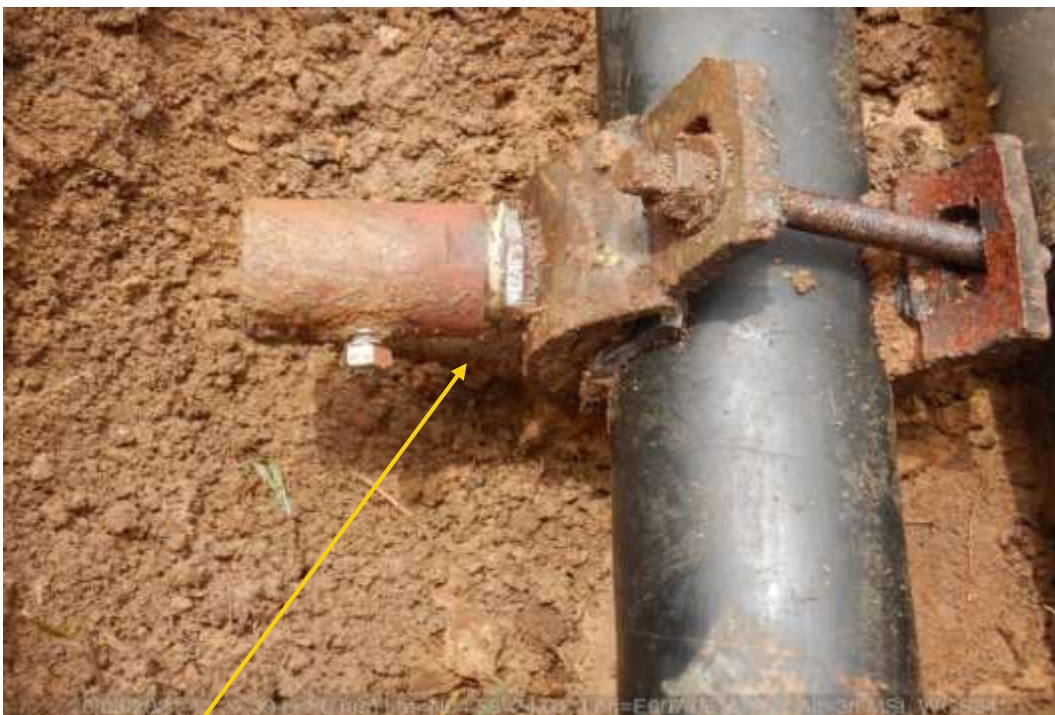
Close-up: SP 1 : Crude oil theft points installed at 3 and 9 o'clock position on 4inch Nkali well 13L/S flowline at Odagwa 2. Picture was taken during Joint Investigation of 26th March 2021.

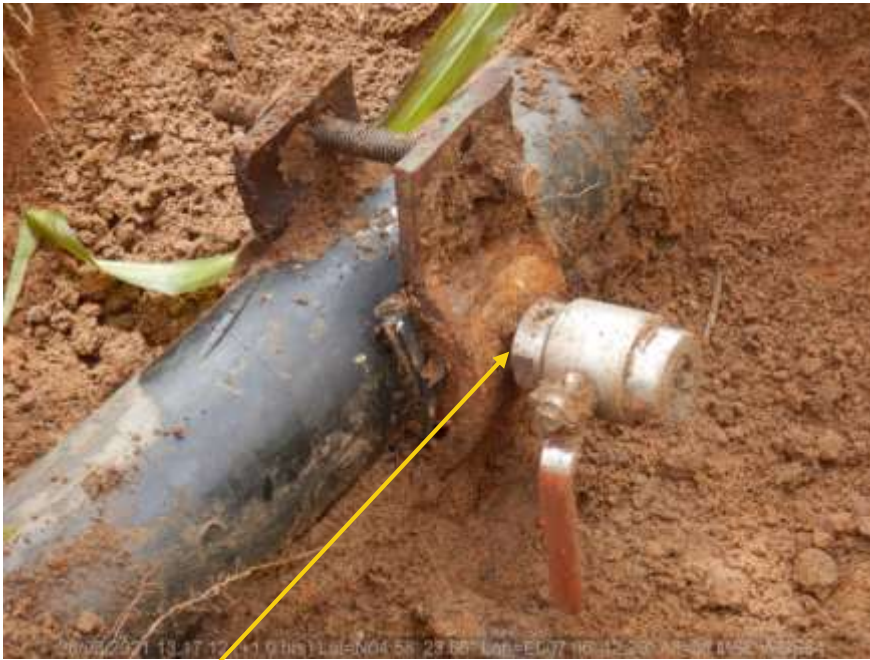
Closeup: SP 2: Crude oil theft points installed at 3 and 9 o'clock position on 4inch Nkali well 13L/S flowline at Odagwa 2. Picture was taken during Joint Investigation of 26th March 2021.
