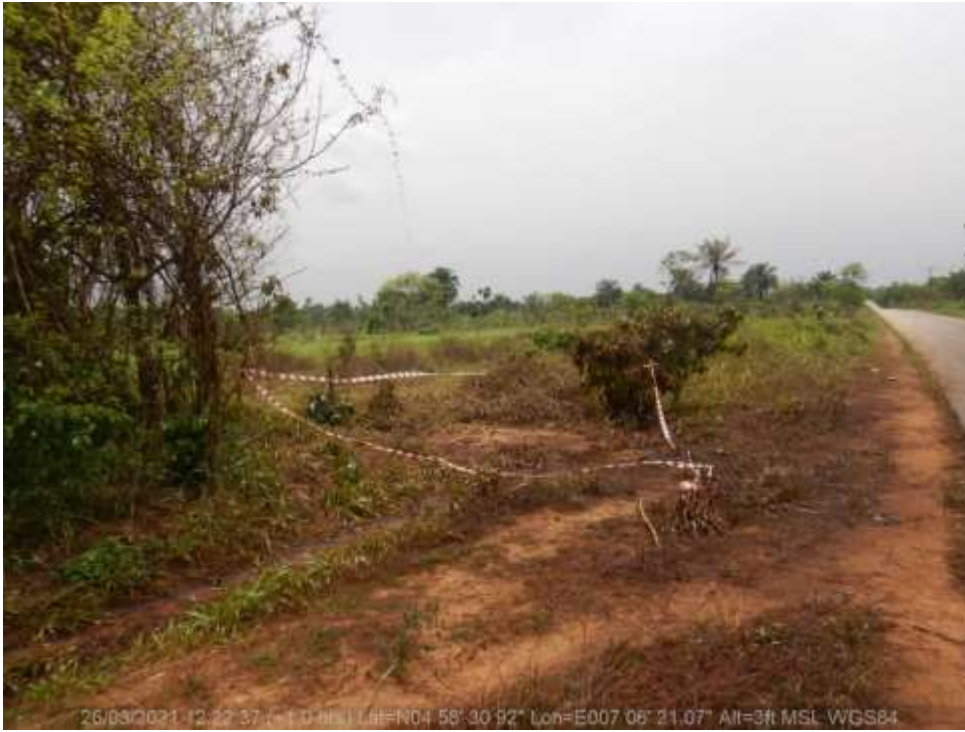
Overview: Part of spill impact on 4inch Nkali well 10S flowline at Odagwa .  
Picture was taken during Joint Investigation of 26<sup>th</sup> March 2021.

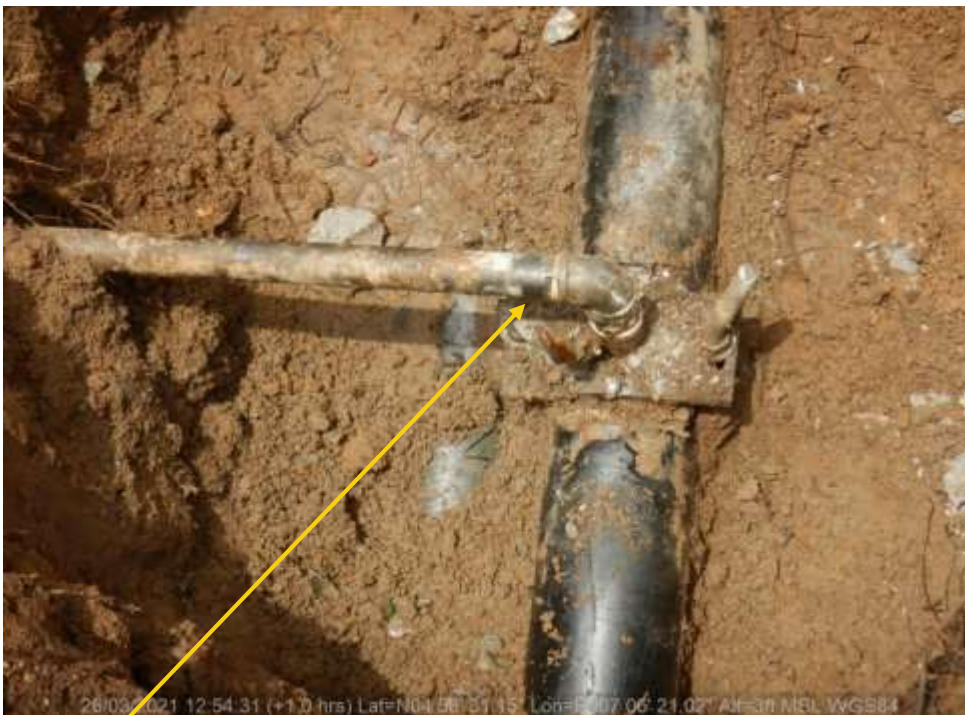
Close-up: SP 1 : Crude oil theft point installed at 12 o'clock position on 4inch Nkali well 10S flowline  
at Odagwa . Picture was taken during Joint Investigation of 26<sup>th</sup> March 2021.
