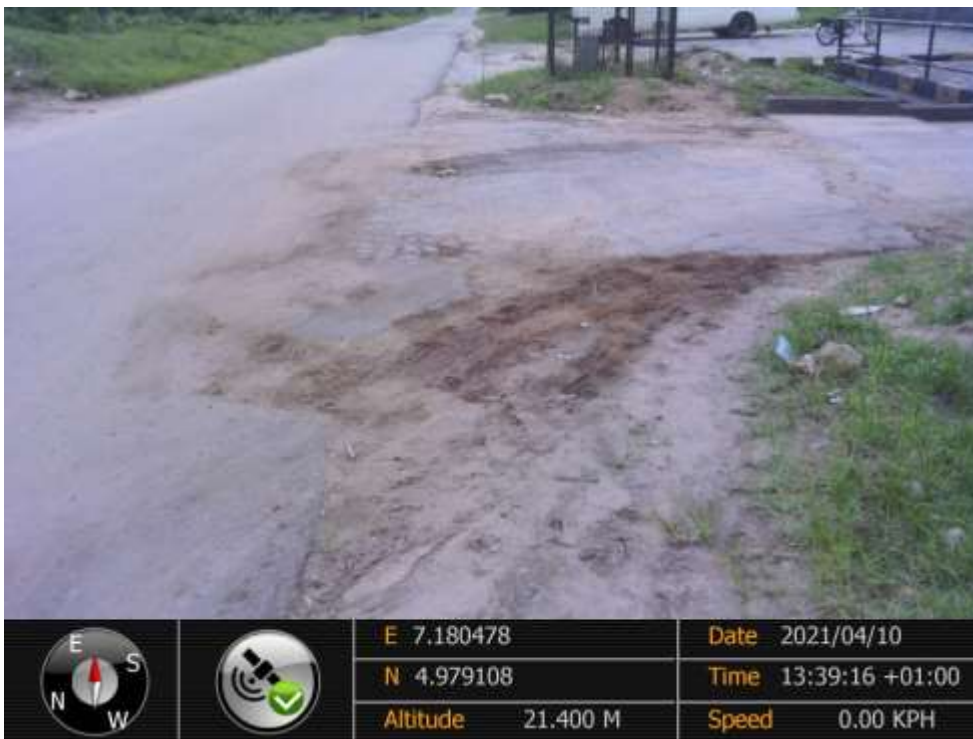
Overview: Part of spill impact on 3inch Imo River Well 63T Flowline at Owaza. Picture was taken during Joint Investigation of 10th April 2021.

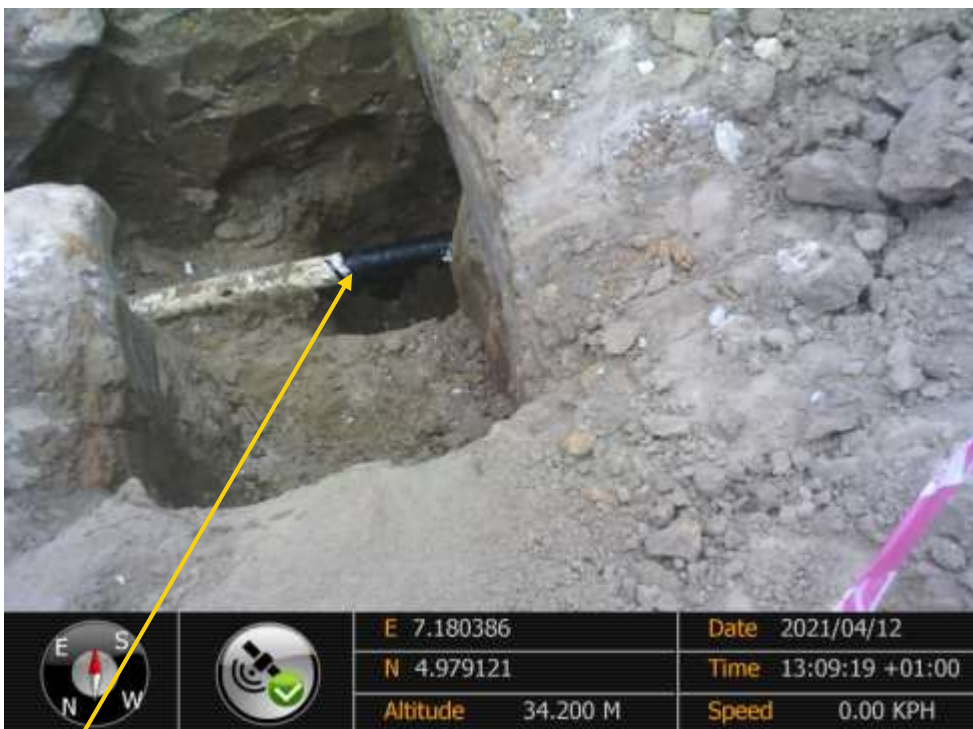
Close-up: Pinhole at 7 o'clock position on 3inch Imo River Well 63T Flowline at Owaza. Picture was taken during Joint Investigation of 12th April 2021.
