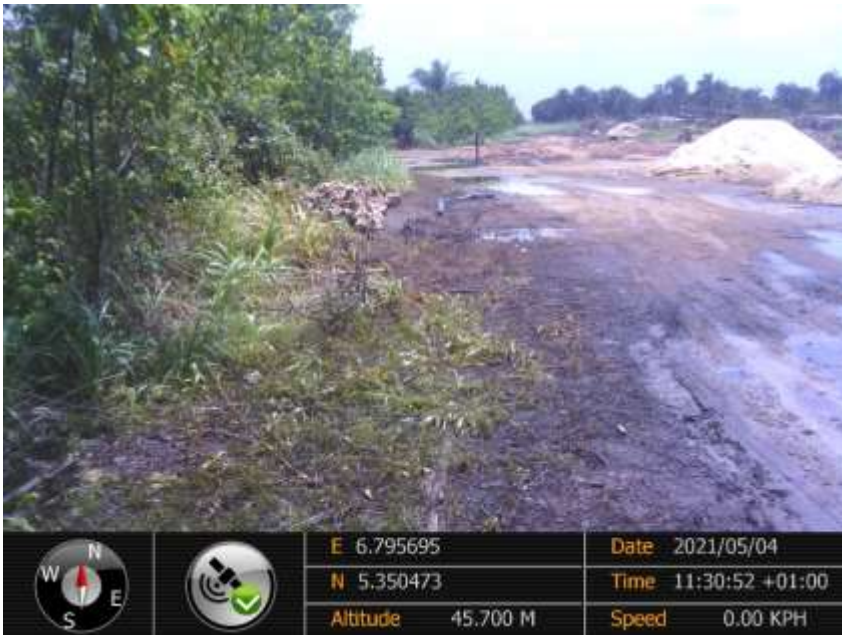
Overview: Part of spill impact on 18inch Assa Rumuekpe Pipeline at Ochia .  
Picture was taken during Joint Investigation of 4<sup>th</sup> May 2021.

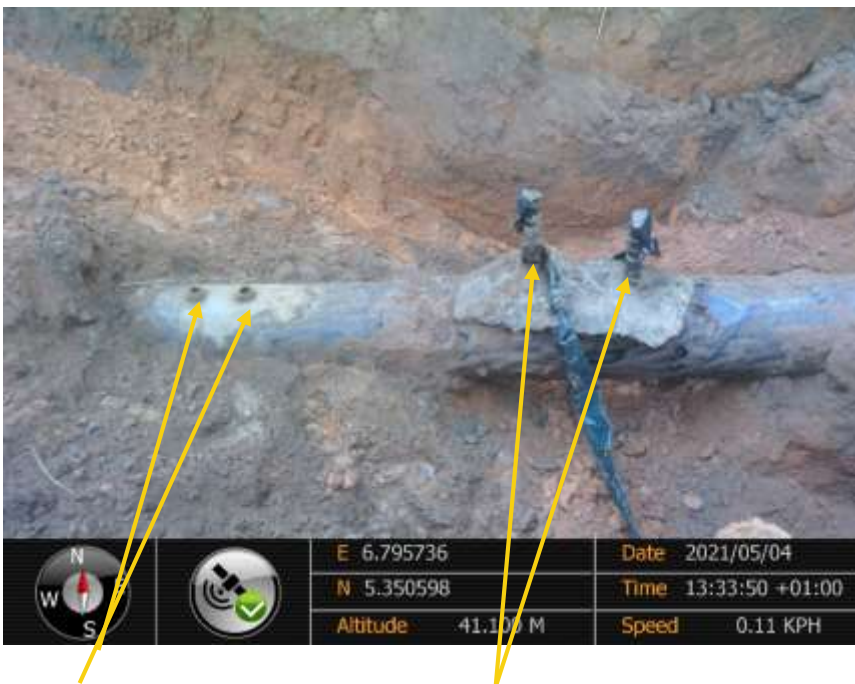
Close-up: 2nos of 2inch non leaking ball valves and 2nos of 2inch leaking ball valves installed at 12 o'clock position on 18inch Assa Rumuekpe Pipeline at Ochia . Picture was taken during Joint Investigation of 4<sup>th</sup> May 2021.
