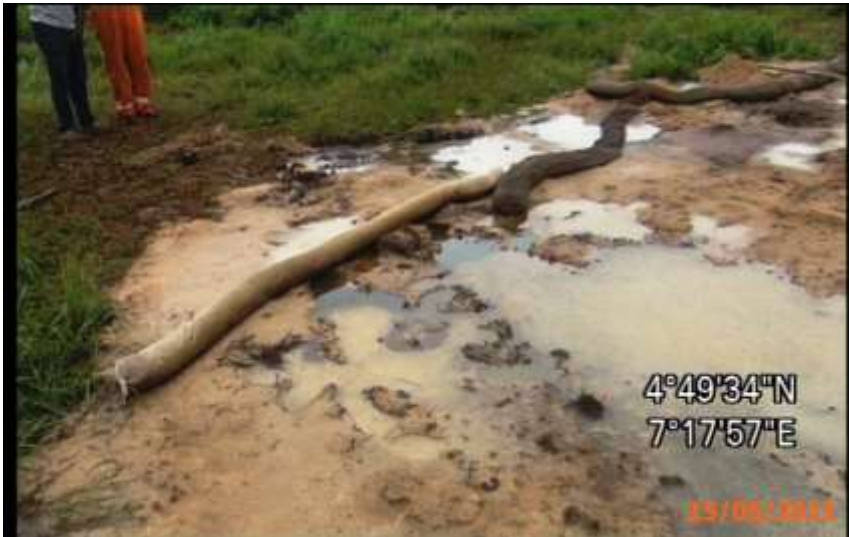
Overview: Part of spill impact on 8inch Afam Well 27T flowline at Egberu. Picture was taken during Joint Investigation of 15<sup>th</sup> May 2021.

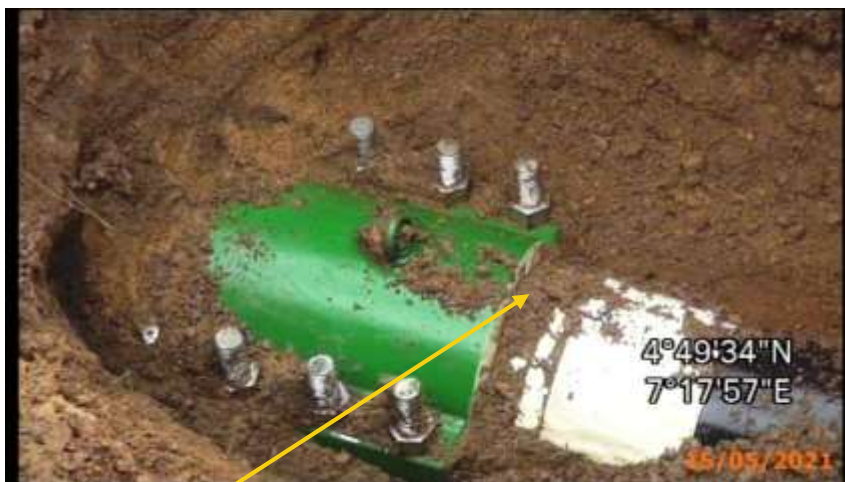
Close-up: A failed Clamp installed to repair a previous clamp incident on 8inch Afam Well 27T flowline at Egberu. Picture was taken during Joint Investigation of 15<sup>th</sup> May 2021.
