# JOINT INVESTIGATION REPORT

INCIDENT NO: 2945559 JIV report S/N: 0300852

1. Fountain Incident Number: 2945559 2. Type of incident: OIL SPILL  
3. Name of Location: 8" AFAM WELL 27T FLOWLINE  
4. Name of nearest community: EGBERU 5. State: RIVERS 6 LGA: OYIGBO  
7. Production Facility/Installation: FLOWLINE  
8. Asset Owner/Hub: THE SHELL PETROLEUM DEVELOPMENT COMPANY OF NIGERIA LTD (SPDC)/LAND EAST HUB

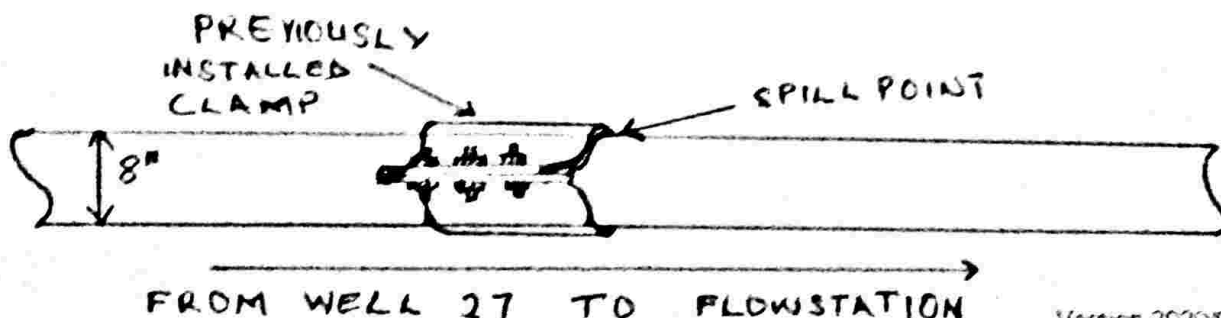
| <input checked="" type="checkbox"/> Others (specify) <u>FAILED CLAMP</u> | | |

E. GRAPHIC DESCRIPTION OF LEAK POINT (while detailed description of the leak point should be contained in the leak report, overview sketch of the site should be added as appendix 1) **A SECTION OF 8" AFAM WELL 27T FLOWLINE ~~SHOW~~ AT EGBERU SHOWING A FAILED CLAMP INSTALLED TO REPAIR A PREVIOUS INCIDENT**

CLAMP REPLACEMENT

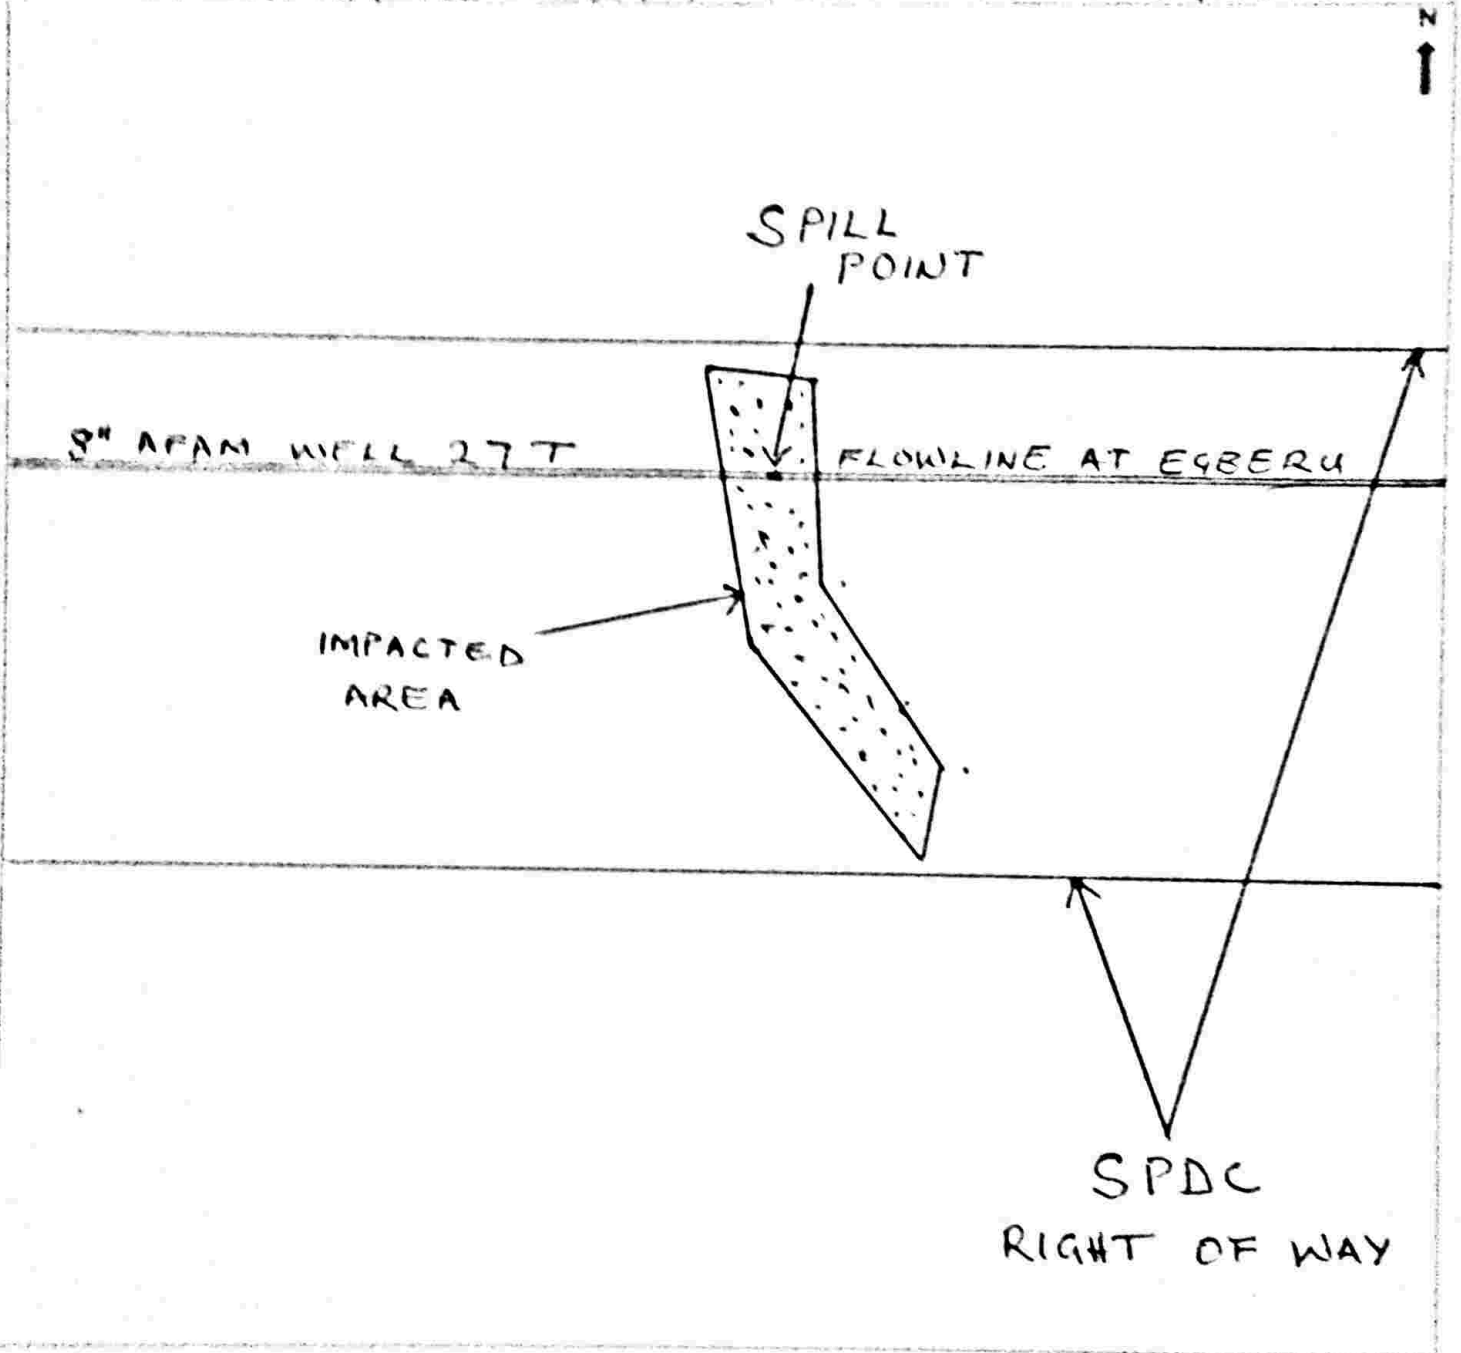
## I. Appendix I: Overview sketch of the site

Location: 8" AFAM WELL 27T FLOWLINE AT EGBERU
