JOINT INVESTIGATION REPORT

INCIDENT NO: 2956152 JIV report S/N: 0000808

1. Fountain Incident Number: 2956152 2. Type of incident* OIL SPILL
3. Name of Location SEIBUD WELL 3
4. Name of nearest community OGBANBIRI 5. State: BAYELSA 6. LGA SOUTHERN ISAW
7. Production Facility/Installation WELL HEAD
8. Asset Owner/Hub THE SHELL PETROLEUM DEVELOPMENT COMPANY NIGERIA LIMITED / SWAMP WEST

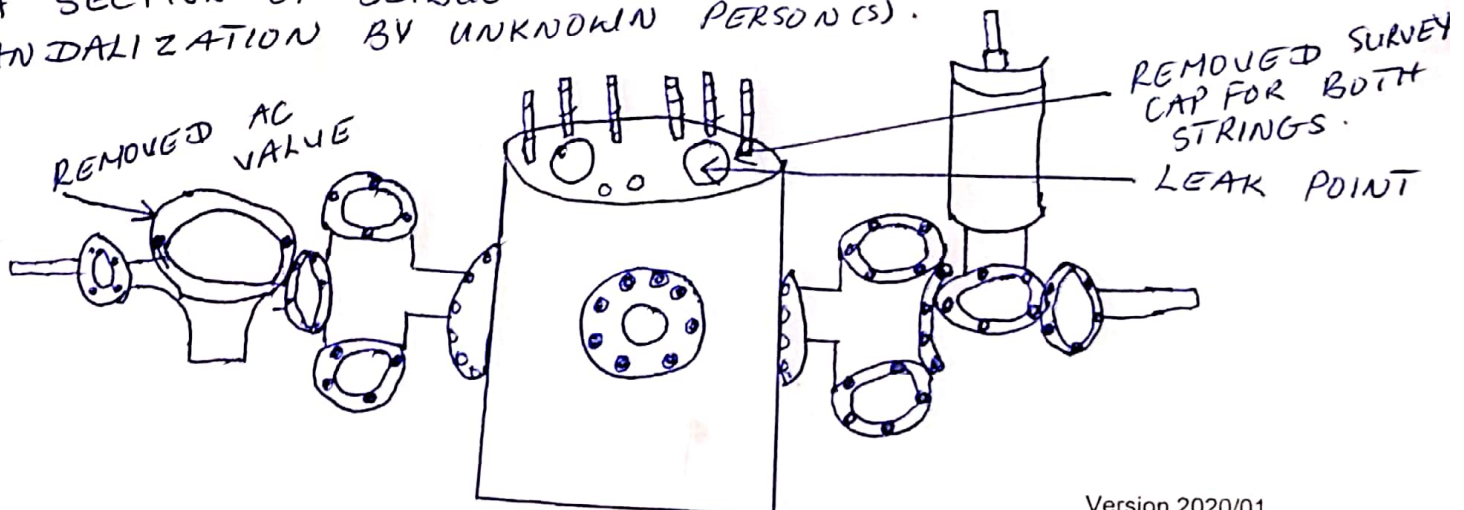
| <input type="checkbox"/> Complete Rupture | <input type="checkbox"/> Inward dent, | <input checked="" type="checkbox"/> Well head tampering |

- ☒ Third party interference (Sabotage ☐; crude theft ☐; Line theft ☐; Accidental 3rd party damage ☐
☐ Operational ☐ Others (including Mystery spills) _____

A SECTION OF SEIBUD WELL 3 AT OGBAINBIRI SHOWING VANDALIZATION BY UNKNOWN PERSON(S).
