JOINT INVESTIGATION REPORT

INCIDENT NO: 2951403 JIV report S/N: 0000907

1. Fountain Incident Number: 2951403 2. Type of incident* OIL SPILL
3. Name of Location: 36" RUMUEKPE-NIKPOKU PIPELINE AT IBAA
4. Name of nearest community IBAA 5. State: RIVERS 6. LGA EMUOHA
7. Production Facility/Installation OIL PIPELINE
8. Asset Owner/Hub THE SHELL PETROLEUM DEVELOPMENT COMPANY - OF NIGERIA LTD (SPDC) / PIPELINE

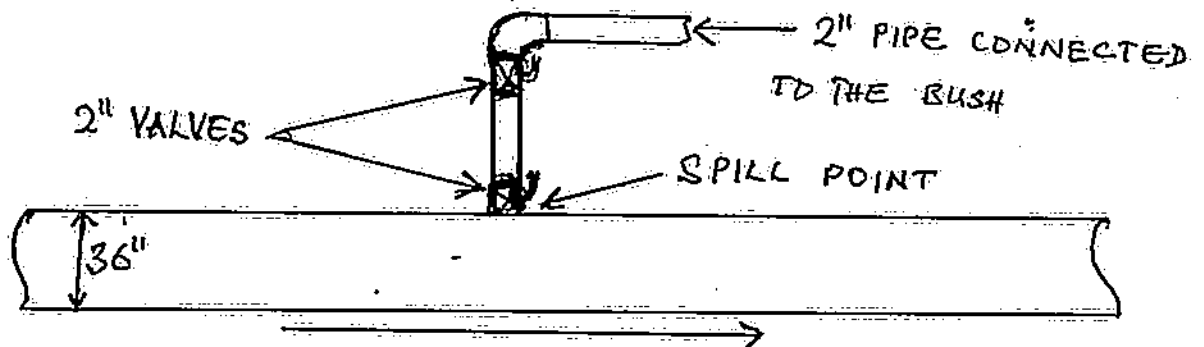
| <input checked="" type="checkbox"/> Crude oil theft (illegal bunkering) point, | <input type="checkbox"/> Saver-pit over flow | <input type="checkbox"/> Third party tampering with Clamp |

- Third party interference (Sabotage crude theft Line theft ; Accidental 3rd party damage
 Operational Others (including Mystery spills) _____

E. GRAPHIC DESCRIPTION OF LEAK POINT (while detailed description of the leak point should be contained in the leak report, overview sketch of the site should be added as appendix 1) **A SECTION OF 36" RUMUEKPE - NKPOKU PIPELINE AT IBAA SHOWING 2" VALVE CRUDE OIL THEFT POINT INSTALLED AT AT 12 O'CLOCK POSITION BY UNKNOWN PERSONS.**

REPAIR BY CLAMPING AND SPILL RECOVERY
