JOINT INVESTIGATION REPORT

INCIDENT NO: 3063126 JIV report S/N: 0000975

1. Fountain Incident Number: 3063126 2. Type of incident* OIL SPILL
3. Name of Location 8" ISIMIRI DELWERT LINE
4. Name of nearest community OBIANKPU 5. State: ABIA 6. LGA UKWA WEST
7. Production Facility/Installation CRUDE OIL DELWERT LINE
8. Asset Owner/Hub THE STEEL PETROLEUM DEVELOPMENT COMPANY OF NIGERIA LIMITED (SPDC) PIPELINE

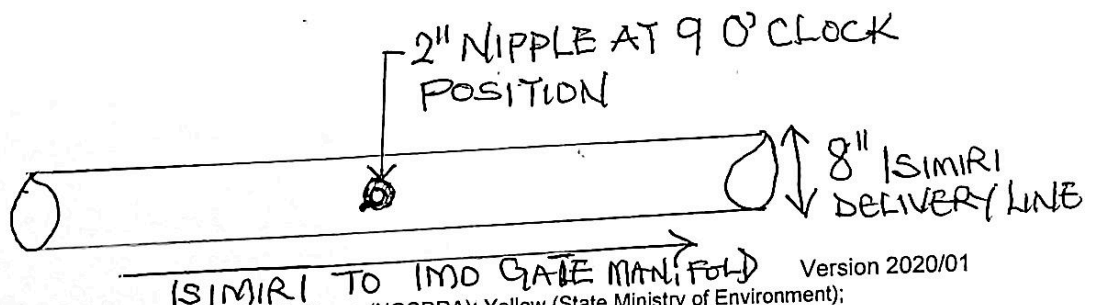
| <input checked="" type="checkbox"/> Crude oil theft (illegal bunkering) point, | <input type="checkbox"/> Saver-pit over flow | <input type="checkbox"/> Third party tampering with Clamp |

E. GRAPHIC DESCRIPTION OF LEAK POINT *(while detailed description of the leak point should be contained in the leak report, overview sketch of the site should be added as appendix 1)* A SECTION OF 8" ISIMIRI DELIVERY LINE AT OBIAKPU SHOWING A 2" NIPPLE INSTALLED AT 9 O'CLOCK POSITION BY UNKNOWN PERSON(S).

REPAIR BY CLAMPING ONGOING
