JOINT INVESTIGATION REPORT

INCIDENT NO: 3062239 JIV report S/N: 0000974

1. Fountain Incident Number: 3062239 2. Type of incident* OIL SPILL
3. Name of Location 4" OBELLE - IBAA DELIVERY LINE
4. Name of nearest community IBAA 5. State: RIVERS 6. LGA EMOTUA
7. Production Facility/Installation CRUDE OIL DELIVERY LINE
8. Asset Owner/Hub THE STELL PETROLEUM DEVELOPMENT COMPANY OF NIGERIA LIMITED (SPDC) PIPELINE.

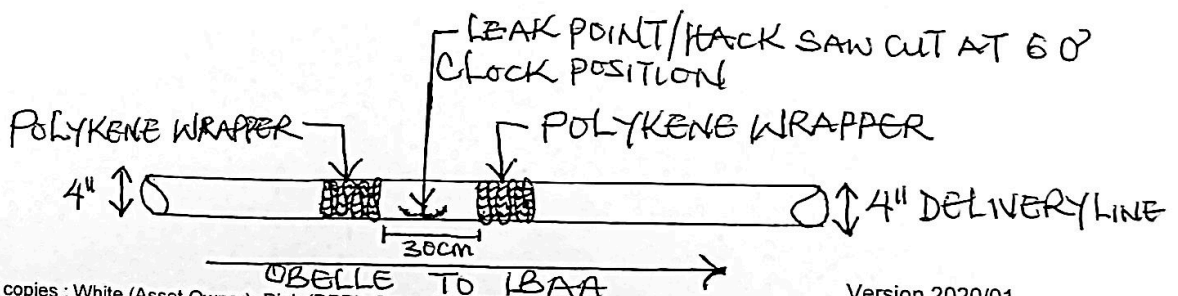
E. GRAPHIC DESCRIPTION OF LEAK POINT (while detailed description of the leak point should be contained in the leak report, overview sketch of the site should be added as appendix 1)

JOINT INVESTIGATION TEAM OBSERVED TWO POINTS WRAPPED WITH POLYKENE WRAPPER AND HAVING A DISTANCE OF ABOUT 30CM APART ALONG THE DELIVERY LINE.

A SECTION OF 4" OBELLE-IBAA DELIVERY LINE AT IBAA SHOWING A HACKSAW CUT ON 6 O' CLOCK POSITION WITH AN ARC DISTANCE OF 90MM DONE BY UNKNOWN PERSON(S). THE HACKSAW CUT IS IN BETWEEN TWO POINTS WRAPPED WITH POLYKENE WRAPPER WITH 30CM DISTANCE APART

REPAIR BY CLAMPING ON-GOING
