Overview: Part of spill impact on 4" Otumara Well 29S Flowline at Otumara.
Picture was taken during Joint Investigation on 21st December 2021.

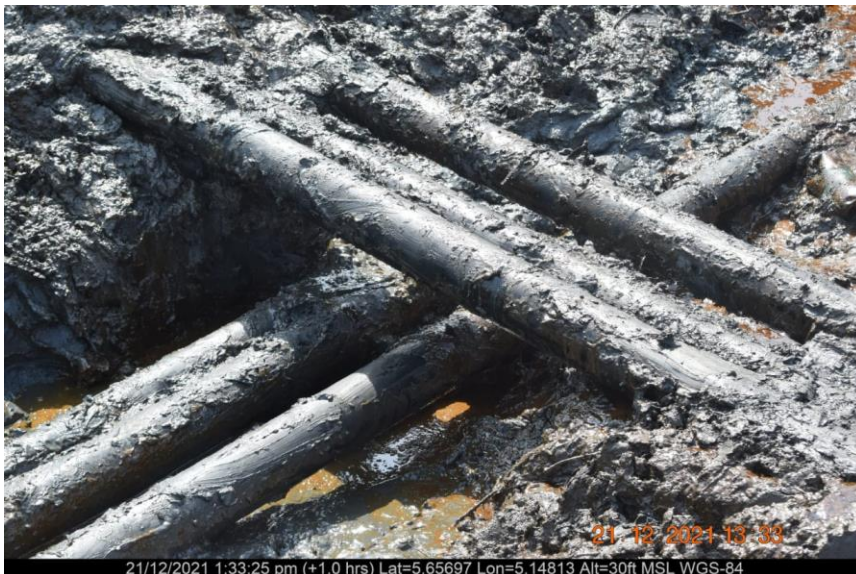
Overview: Part of spill impact on 4" Otumara Well 29S Flowline at Otumara.
Picture was taken during Joint Investigation on 21st December 2021.

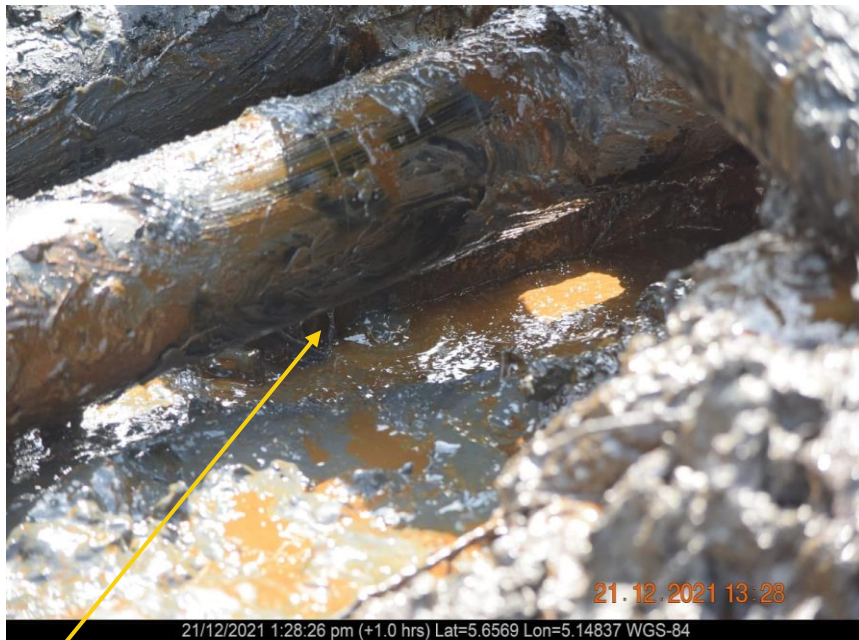
Close-up: Pin hole due to corrosion at 6 o'clock position on 4" Otumara Well 29S Flowline at Otumara. Picture was taken during Joint Investigation on 21st December 2021.
