JOINT INVESTIGATION REPORT

INCIDENT NO: 3059858 JIV report S/N: 0000971

1. Fountain Incident Number: 3059858 2. Type of incident* OIL SPILL
3. Name of Location 28" OGALE - BOMU PIPELINE
4. Name of nearest community AGBONCITA 5. State: RIVERS 6. LGA ELEME
7. Production Facility/Installation CRUDE OIL PIPELINE
8. Asset Owner/Hub THE SHELL PETROLEUM DEVELOPMENT COMPANY OF NIGERIA LIMITED (SPDC) PIPELINE

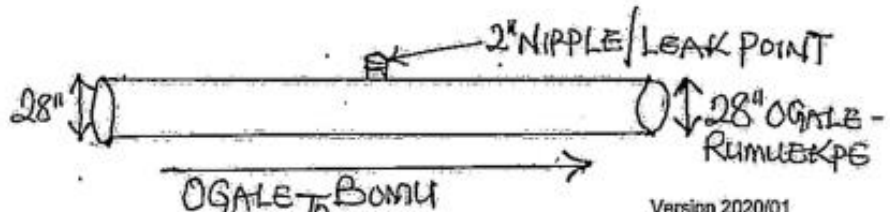
| <input checked="" type="checkbox"/> Crude oil theft (illegal bunkering) point, | <input type="checkbox"/> Saver-pit over flow | <input type="checkbox"/> Third party tampering with Clamp |

- Third party interference (Sabotage ; crude theft ; Line theft ; Accidental 3rd party damage
 Operational Others (including Mystery spills) _____

in the leak report, overview sketch of the site should be added as appendix 1) A SECTION OF 28" OGALE-BORU PIPELINE AT AGBONCHIA SHOWING A 2" NIPPLE INSTALLED AT 12 O'CLOCK POSITION BY UNKNOWN PERSON(S).

REPAIR BY CLAMPING ON-GOING
