# JOINT INVESTIGATION REPORT

INCIDENT NO: 3046649 JIV report S/N: 0001049

1. Fountain Incident Number: 3046649 2. Type of incident\* OIL SPILL  
3. Name of Location 18" ASSA - RUMUKEPE PIPELINE  
4. Name of nearest community DCHIA 5. State: IMO 6. LGA OHAJI EGBENIA  
7. Production Facility/Installation CRUDE OIL PIPELINE  
8. Asset Owner/Hub THE SHELL PETROLEUM DEVELOPMENT COMPANY  
OF NIGERIA LIMITED / PIPELINE

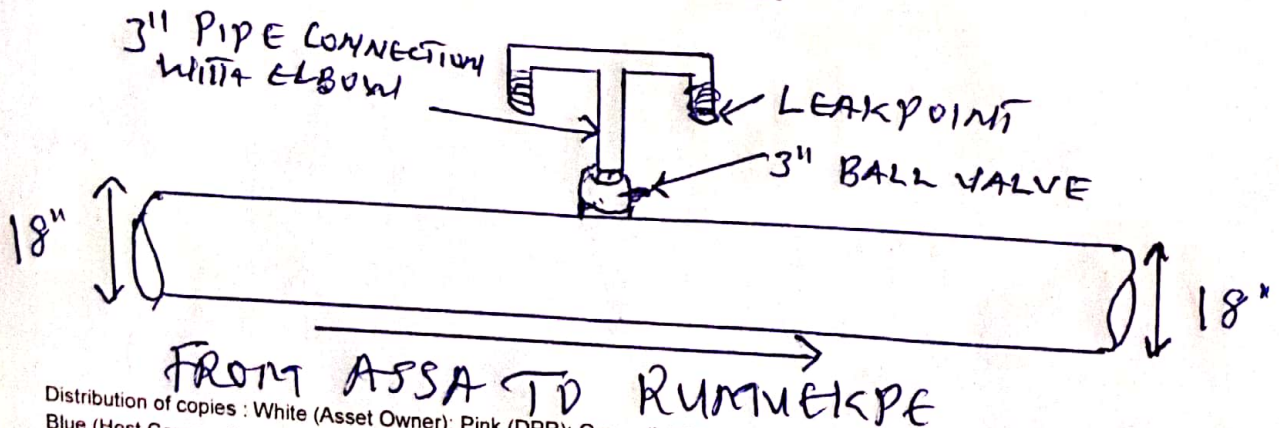
Additional observations around the spill point: DURING THE JOINT INVESTIGATION VISIT, THE TEAM OBSERVED LEAK FROM THE EARLIER REPORTED NON LEAKING POINT OF ILLEGAL CONNECTION WITH FID: 2461898. FLEXIBLE HOSES WERE ALSO OBSERVED.

| <input checked="" type="checkbox"/> Failed Weld-on illegal hot tap valve | <input type="checkbox"/> Failed Clamp, | <input type="checkbox"/> Missing Pipeline/Flowline |
| <input checked="" type="checkbox"/> Crude oil theft (illegal bunkering) point, | <input type="checkbox"/> Saver-pit over flow | <input type="checkbox"/> Third party tampering with Clamp |

SECTION OF 18" ASSA - RUMUEKPE PIPELINE AT UCHIA SHOWING CRUDE OIL TEE POINT INSTALLED AT 12 O'CLOCK POSITION BY UNKNOWN PERSONS

OIL SPILL RESPONSE AND REPAIR ACTIVITIES ARE ONGOING.
