INCIDENT NO: 3046696 JIV report S/N:0000994

OFFICE AL INFORMATION.		
GENERAL INFORMATION:	~ ^	M. 50.11
Fountain Incident Number: 30466		ent* OIL SPILL
Name of Location 12" (mo RIVER 1	- OGALE PIPELINE	-
Name of nearest community Union	LO 5. State: ABIA	S. LGA UKWA WEST
Production Facility/Installation O1L		
Anna Commention THE CHELL C	SETUNIEUM NEUELAUM	ENT COMPANY OF NIGERIA LIM
PIPEL	NE.	ENT COMPANY OF NIGERIA LIM
INCIDENT INFORMATION:		
Details of incident a. Date Reported: 14TH OCTOBER	2621

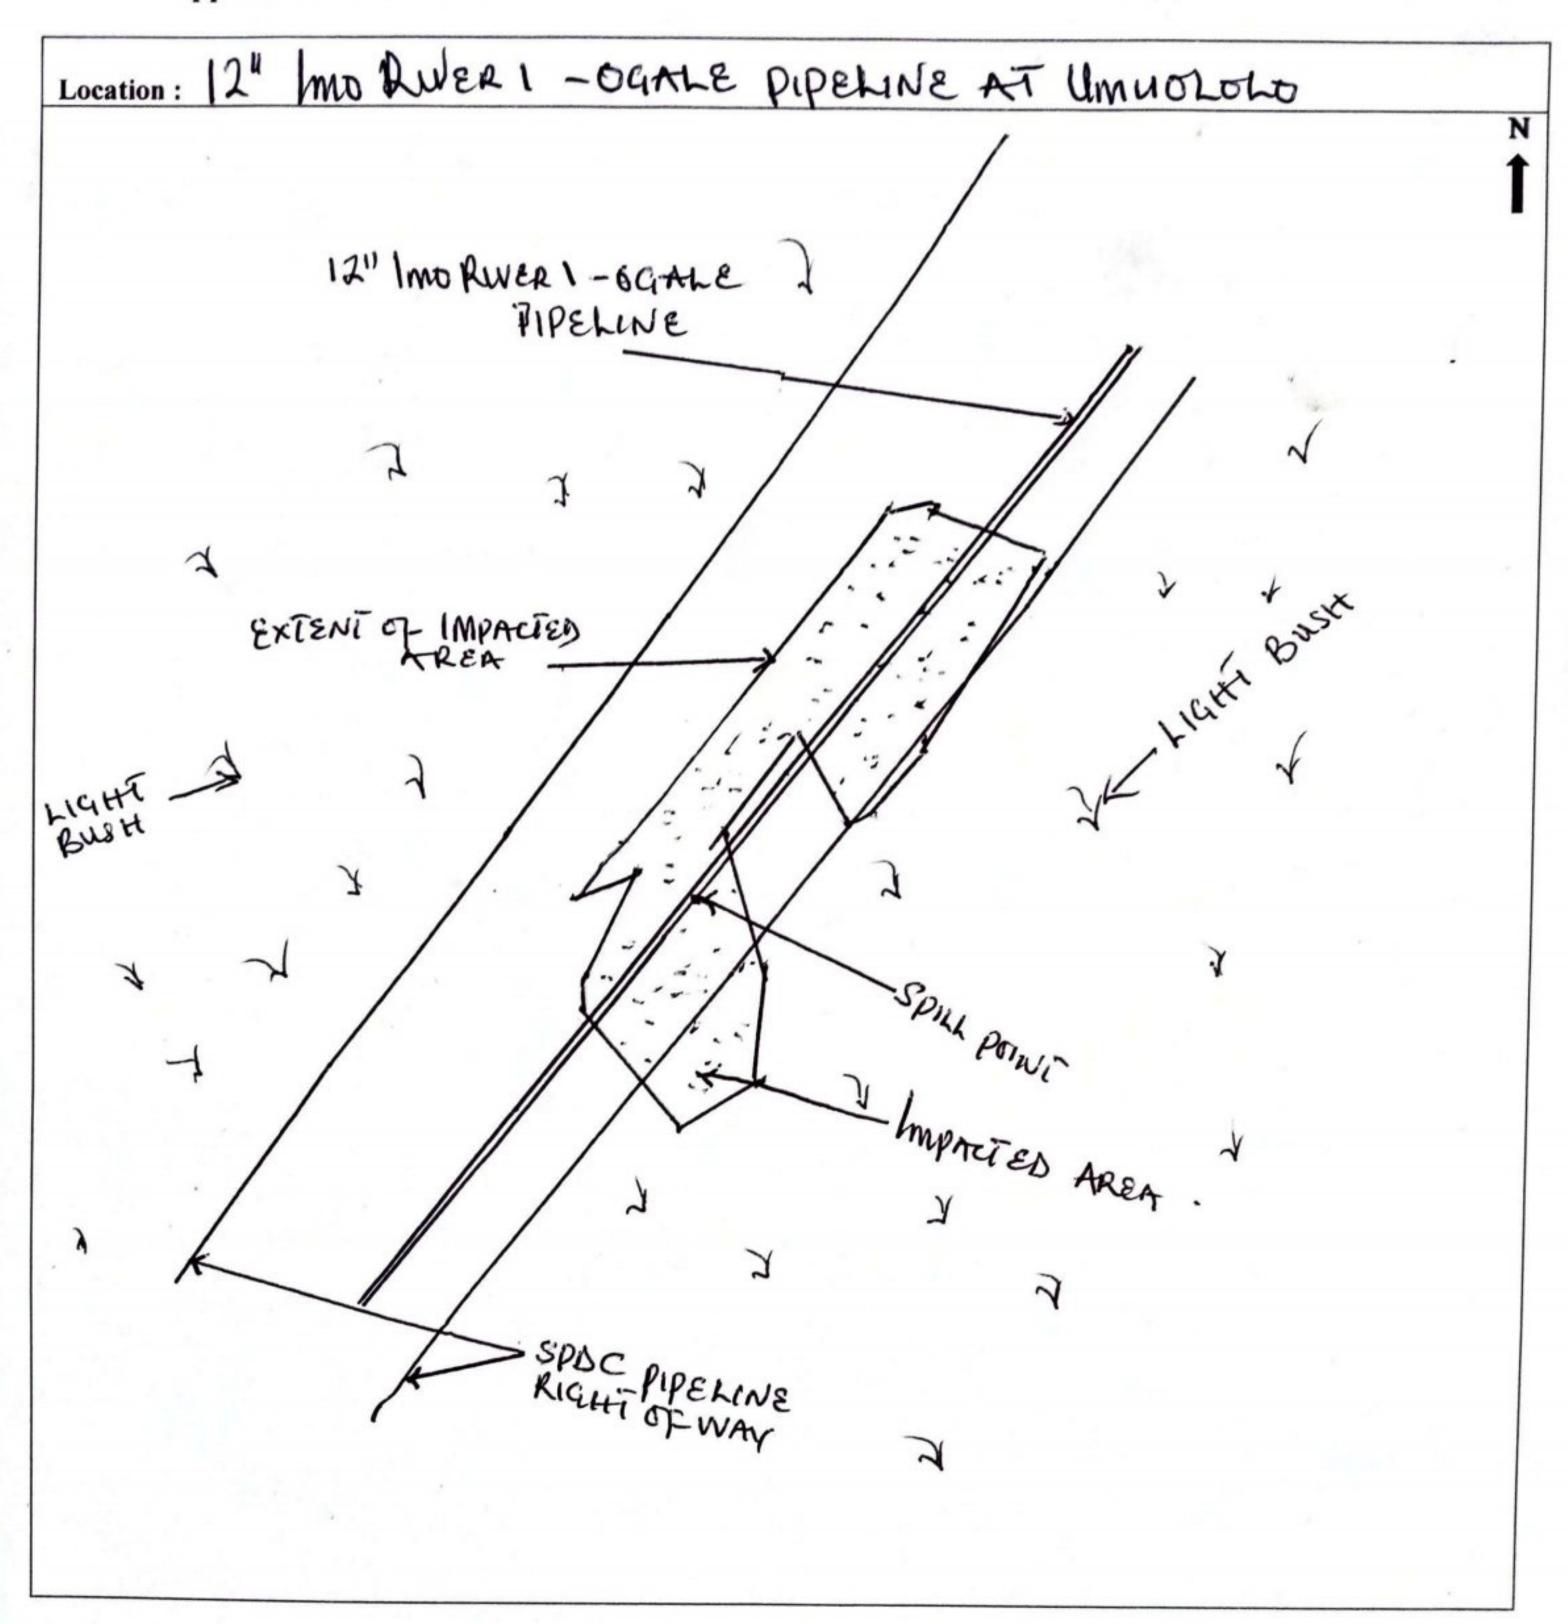
f. Appendix 1: Overview sketch of the site

E. GRAPHIC DESCRIPT in the leak report, overview - OGALE PIPELIT HOLE AT 12 0'C	sketch	of the site show	uld he added as	cannondir 1) A	CCAS		7 11 110 V
			SPILL POINT	SMOOTH &	METER		
12"						Jį.	2.4
	F	Rom Ima Ru	WERT TO	SLADO
