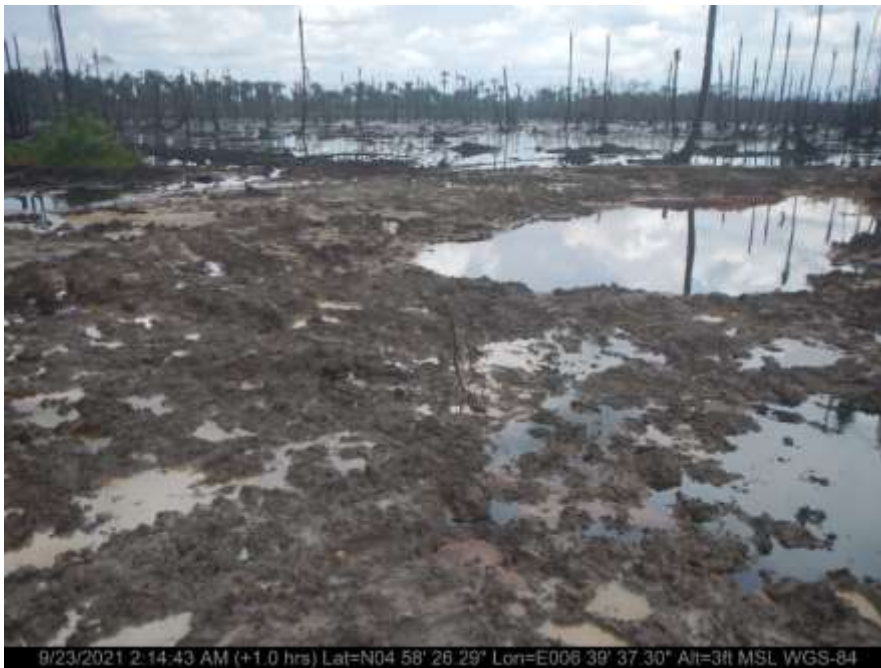
Overview: Part of spill impact on 20" Kolocreek \_Rumuekpe Trunkline at Okoma. Picture was taken during Joint Investigation of 23<sup>rd</sup> September 2021.

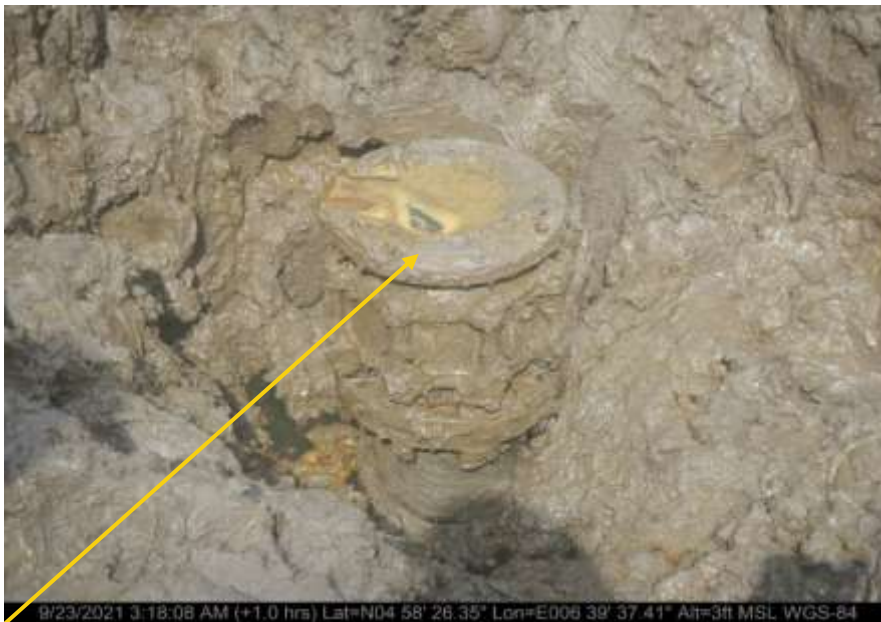
Close-up: 8inch ball valve installed at 12 o'clock position on 20" Kolocreek \_Rumuekpe Trunkline at Okoma. Picture was taken during Joint Investigation of 23<sup>rd</sup> September 2021.
