# JOINT INVESTIGATION REPORT

INCIDENT NO: 3029566 JIV report S/N: 0001015

1. Fountain Incident Number: 3029566 2. Type of incident\* OIL SPILL  
3. Name of Location 20" TRANS ESCRAVOS PIPELINE  
4. Name of nearest community UGBOGUNGUN State: DELTA 6. LGA WARRI SOUTH WEST  
7. Production Facility/Installation PIPELINE  
8. Asset Owner/Hub THE SHELL PETROLEUM DEVELOPMENT COMPANY NIGERIA LIMITED / PIPELINE

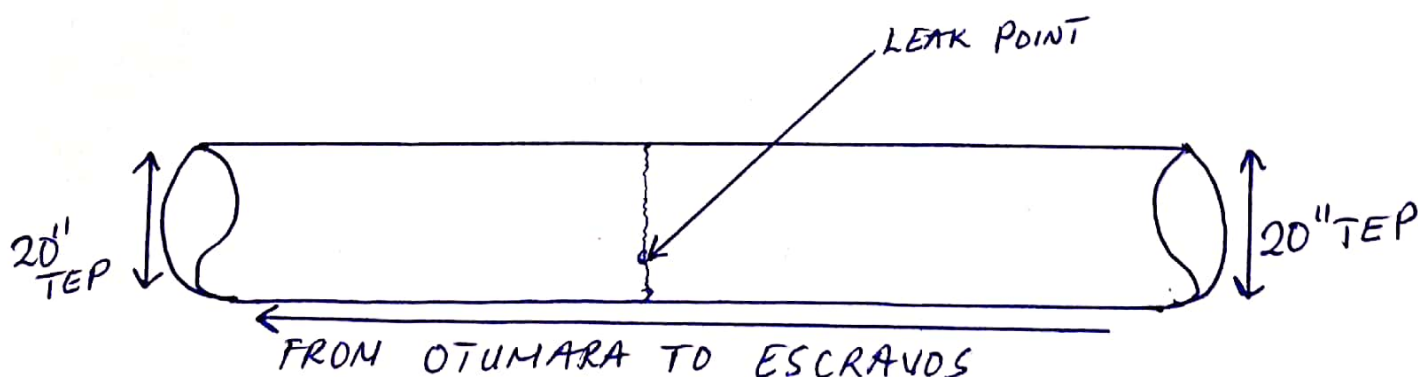
| <input checked="" type="checkbox"/> Others (specify) <u>A PIN HOLE DUE TO CORROSION</u> | | |

A SECTION OF 20" TRANS ESCRAVOS PIPELINE AT UGBOEGUNGUN SHOWING A PIN HOLE AT 9 O'CLOCK POSITION.
