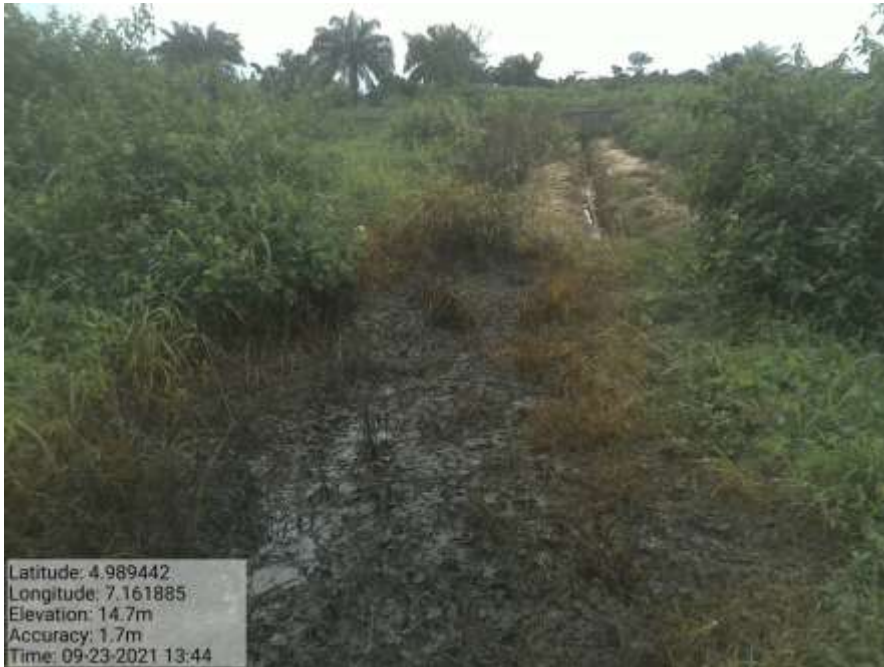
Overview: Part of spill impact on 4" ImoRiver well 58T flowline at Odagwa.  
Picture was taken during Joint Investigation of 23<sup>rd</sup> September 2021.

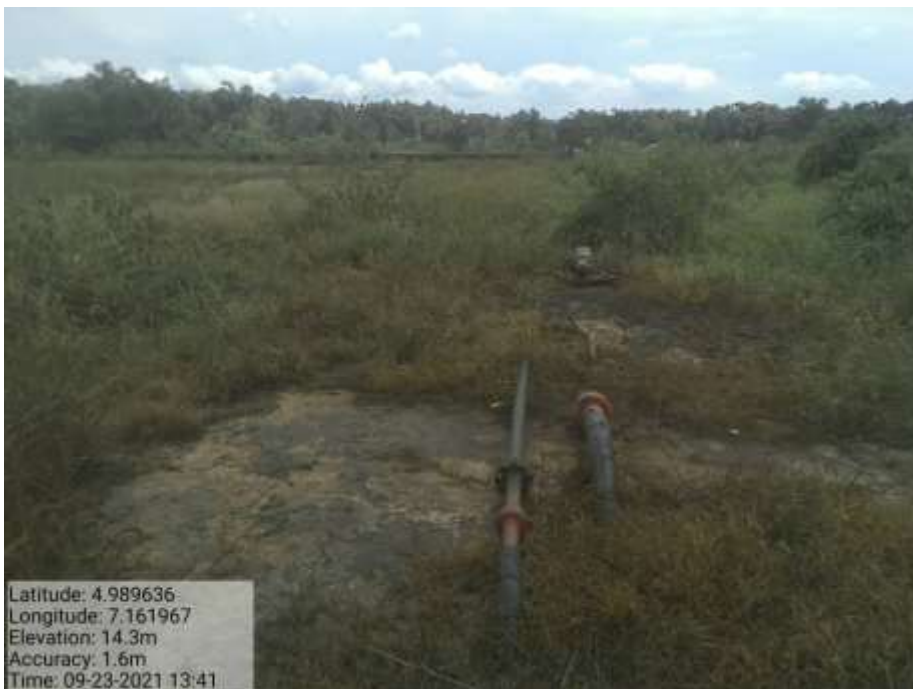
Close-up: Missing Flowline on 4" ImoRiver well 58T flowline at Odagwa.  
Picture was taken during Joint Investigation of 23<sup>rd</sup> September 2021.
