# JOINT INVESTIGATION REPORT

INCIDENT NO: 3035490 JIV report S/N: 0001045

1. Fountain Incident Number: 3035490 2. Type of incident\* OIL SPILL  
3. Name of Location 4" OBELE - IBAA DELIVERY LINE  
4. Name of nearest community IBAA 5. State: RIVERS 6. LGA EMOHUA  
7. Production Facility/Installation CRUDE OIL DELIVERY LINE  
8. Asset Owner/Hub THE SHELL PETROLEUM DEVELOPMENT COMPANY OF NIGERIA LIMITED / PIPELINE

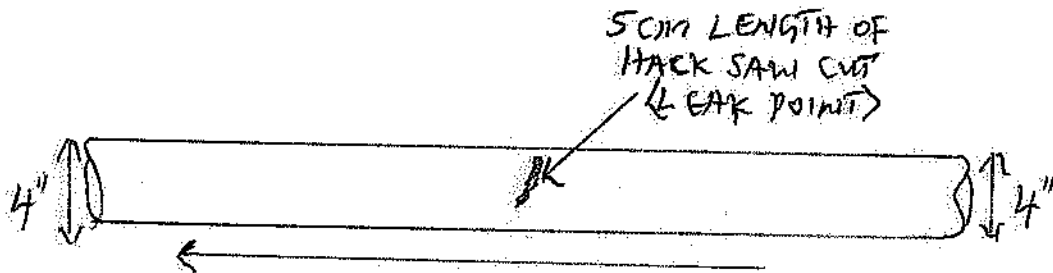
| <input type="checkbox"/> Smooth round-edge hole | <input type="checkbox"/> Rough-edge hole | <input checked="" type="checkbox"/> Hack saw cut |

- Third party interference (Sabotage ; crude theft ; Line theft ; Accidental 3<sup>rd</sup> party damage   
 Operational  Others (including Mystery spills) \_\_\_\_\_

SECTION OF 4" OBELE ~ IBAA DELIVERY LINE AT IBAA SHOWING G  
 HACK SAW CUT BY UNKNOWN PERSON(S) AT 9-11 O'CLOCK  
 POSITION.
