# JOINT INVESTIGATION REPORT

INCIDENT NO: 3025072 JIV report S/N: 0000963

1. Fountain Incident Number: 3025072 2. Type of incident\* OIL SPILL  
3. Name of Location 12" OGUTA - EGBEMA PIPELINE  
4. Name of nearest community UMUNKHU 5. State: IMO 6. LGA OGUTA  
7. Production Facility/Installation CRUDE OIL PIPELINE  
8. Asset Owner/Hub THE SHELL PETROLEUM DEVELOPMENT COMPANY  
OF NIGERIA LIMITED / PIPELINE

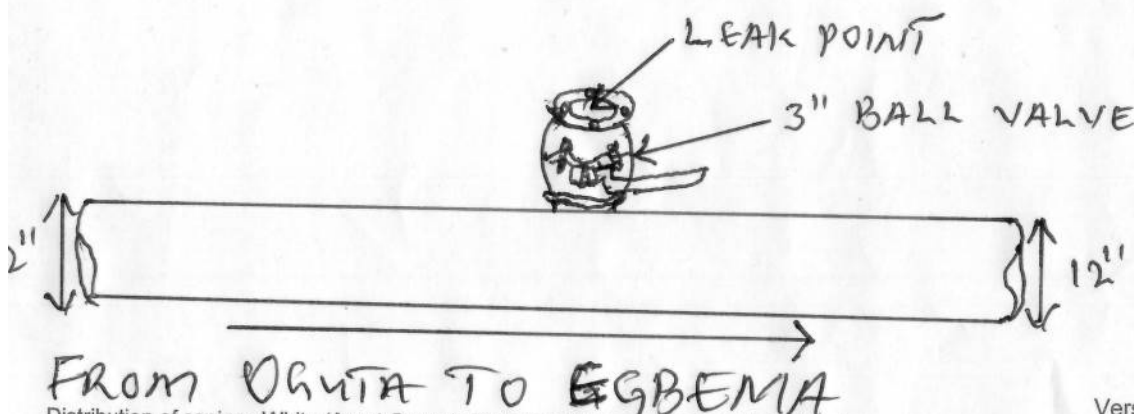
| <input checked="" type="checkbox"/> Failed Weld-on illegal hot tap valve | <input type="checkbox"/> Failed Clamp, | <input type="checkbox"/> Missing Pipeline/Flowline |
| <input checked="" type="checkbox"/> Crude oil theft (illegal bunkering) point, | <input type="checkbox"/> Saver-pit over flow | <input type="checkbox"/> Third party tampering with Clamp |

- ☒ Third party interference (Sabotage ☐; crude theft ☒; Line theft ☐; Accidental 3<sup>rd</sup> party damage ☐  
☐ Operational ☐ Others (including Mystery spills) \_\_\_\_\_

SECTION OF 12" OGUJA - EGBEMA PIPELINE AT UMMUKHIN  
SHOWING CRUDE OIL THEFT POINT INSTALLED AT 12 O'CLOCK  
POSITION BY UNKNOWN PERSON(S).

REPAIR AND CRUDE OIL RECOVERY ACTIVITIES  
ARE ONGOING
