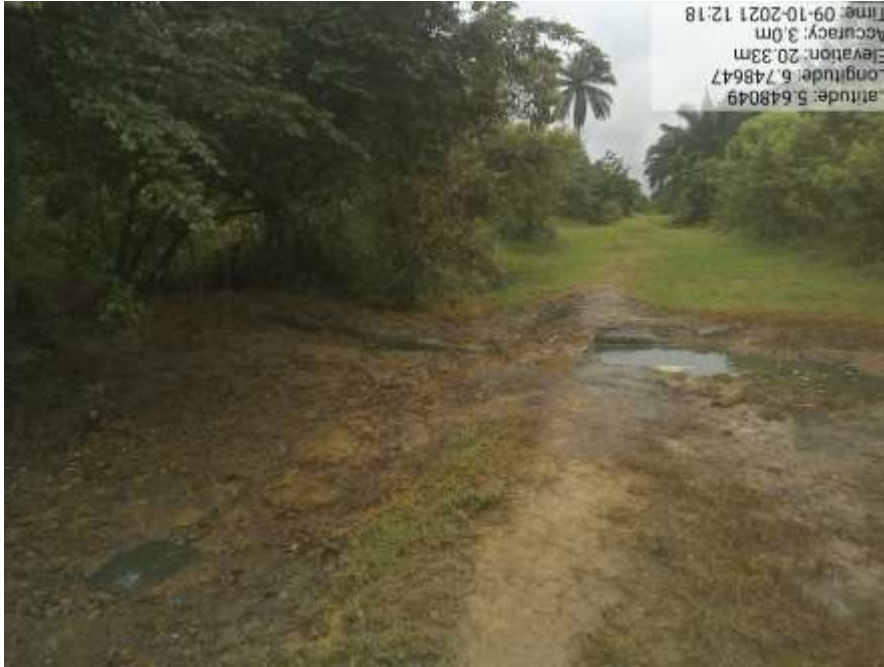
Overview: Part of spill impact on 12" Oguta Egbema Pipeline at Umunkwu. Picture was taken during Joint Investigation of 10<sup>th</sup> September 2021.

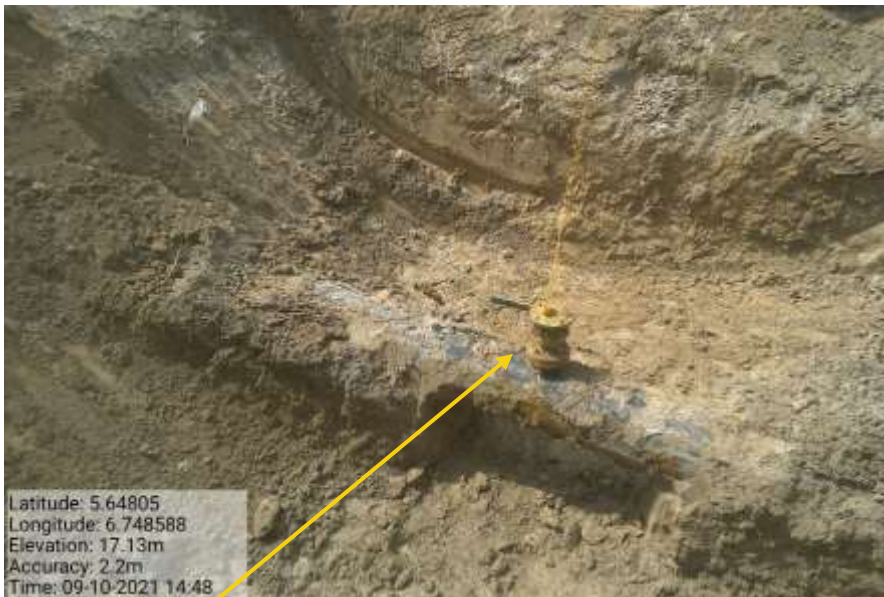
Close-up: Crude oil theft point installed at 12 o'clock position on 12" Oguta Egbema Pipeline at Umunkwu. Picture was taken during Joint Investigation of 10<sup>th</sup> September 2021.
